Stock Condition Survey 2009

Carried Out By: Richard Robertson, Antony Duffy and Owen Holleway Reference No: **Dundee** Location: **Rosendael**

Date: 30th March 2009

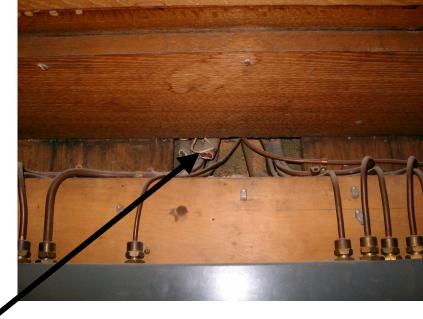
Redundant cables should be removed.

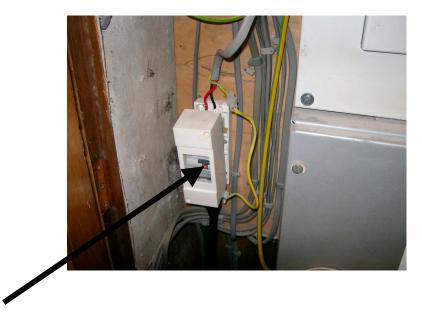
• A CB has been installed with the protective cover incorrectly fitted.

Cover not fitted properly.

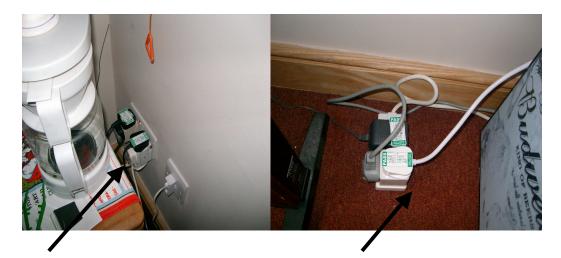
3-way adapters in use

particularly worrying, a 3-way adapter plugged into an extension lead

Power distribution was via a mix of Wylex, GEC and Merlin Gerin DBs located around the bld. Wiring was contained within trunking. This also houses the IT & Telephone system. All were in a fair condition with no defects noted. However there was evidence of extension leads and 3-way adapters in use throughout the bld. This can lead to an overload of the circuits, it is recommended that the use of extensions is reviewed and the removal of 3-way adapters is considered.

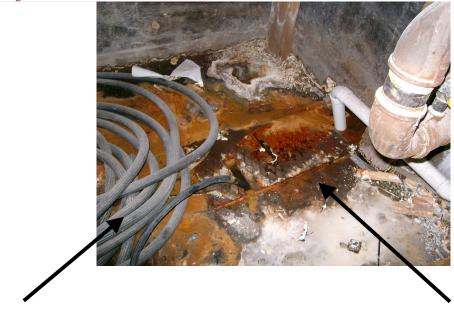
Redundant Hose

Water pooling on floor.

Heating was provided by 2 Remeha Quinta 65 Gas fired boilers. Hot water from system was pumped round the bld to a number of convection radiators, by a Grundfos pumping setup. The heating and its associated equipment were in fair condition with no defects noted. However within the boiler room there was evidence of water pooling on the floor, the source of this is unknown and should be investigated further. There was also a hose within the boiler room which appeared to be redundant; it is recommended that its purpose be ascertained.

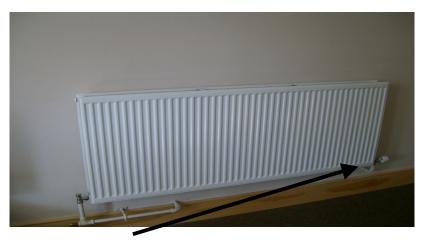
TRV operation to check

Heating was provided by 2 Remeha Quinta 65 Gas fired boilers. Hot water from the system was pumped round the bld to a number of convection radiators, by a Grundfos pumping setup. The heating and its associated equipment were in fair condition however it was noted that the control of the radiators via the TRV's was poor, within rooms 3, 5 & 7 the radiators were cold when on settings 3 & 4, when TRV turned slightly the radiator appeared to heat to maximum temperature. It is recommended that the set up of the TRV's is investigated.

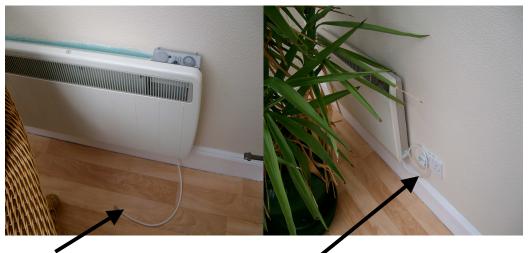
Within the Conservatory two Dimplex Electric have been installed, however one of them has been plugged into the ring main and the other has still to be connected. As these heaters have been fixed to the wall they are now a fixed source of heating therefore it is recommended that they be supplied by a dedicated circuit.

Still to be connected

Connected via a standard plug
