Scottish Veterans'  
Housing Association

## Stock Condition Survey 2009

Date: **24th March 2009**

Reference No: **Edinburgh**  
Location:  
**Gilmerton Lodge**

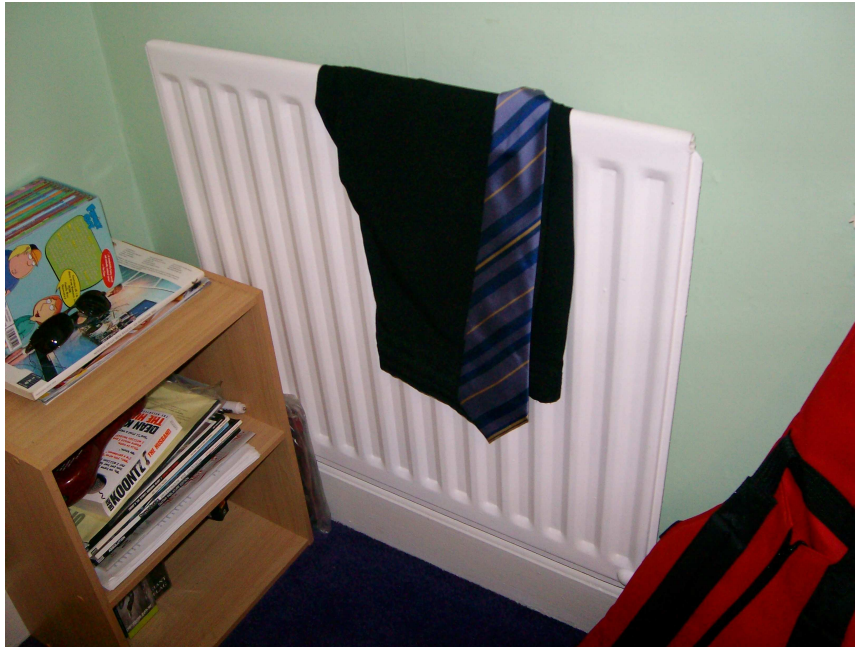
The heating and its associated equipment were in fair condition; however it was stated that bedroom 2 was very cold, it is recommended that the BTU of radiator fitted at present be reviewed. Current radiator fitted is a single radiator, 750X700mm; this appears to be too small for the room.

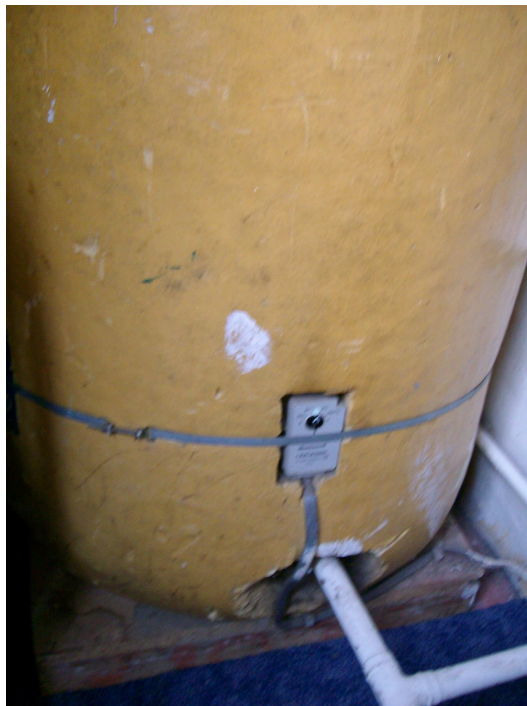
Hot water was supplied by the Combi-boiler to the kitchen, toilet and bathroom. The condition of these was fair with no defects noted. However there is a DHW Calorifier still in place. At the time of survey it was not clear of this was still in use. The technology involved on the current heating/hot water boiler there is no need for a calorifier. In order to reduce the risk of Legionella, it is recommended that the calorifier be decommissioned and removed.

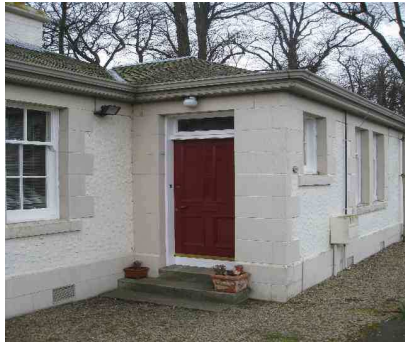
Photo 1

Description	Condition	Action	Cond/Ind	Priority	L'Expec	Quantity	Replacement Cost (£)	Year 1 Repair Cost (£)
Render	Fair	No Action Required	B		10	2 m2	109

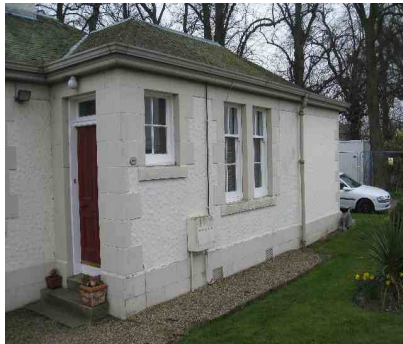
**Photo 1**

Description	Condition	Action	Cond/Ind	Priority	L'Expec	Quantity	Replacement Cost (£)	Year 1 Repair Cost (£)
Render	Fair	No Action Required	B		10	15 m2	820

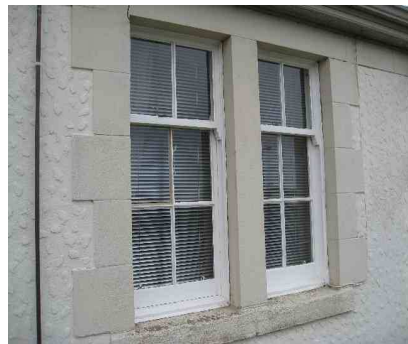
Photo 1

Description	Condition	Action	Cond/Ind	Priority	L'Expec	Quantity	Replacement Cost (£)	Year 1 Repair Cost (£)
Timber softwood sash and case single glazed	Fair	No Action Required	B		10	3 m2	1,230

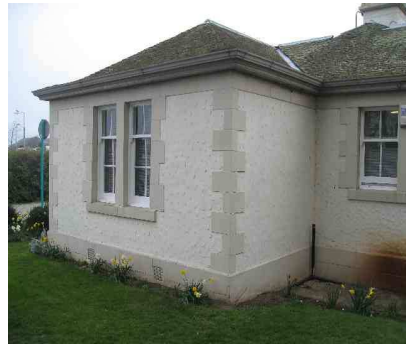
Photo 1

Description	Condition	Action	Cond/Ind	Priority	L'Expec	Quantity	Replacement Cost (£)	Year 1 Repair Cost (£)
Render	Fair	No Action Required	B		10	8 m2	437

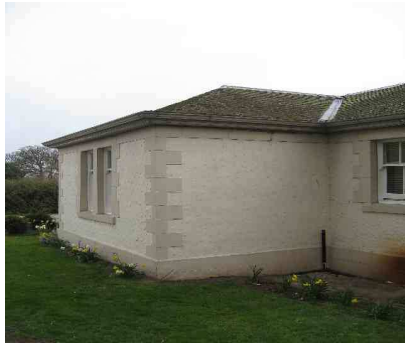
**Photo 1**

Description	Condition	Action	Cond/Ind	Priority	L'Expec	Quantity	Replacement Cost (£)	Year 1 Repair Cost (£)
Render	Fair	No Action Required	B		10	6 m2	328

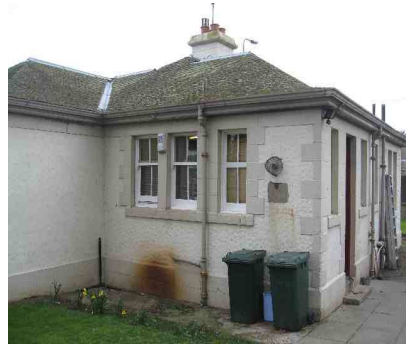
Photo 1

Description	Condition	Action	Cond/Ind	Priority	L'Expec	Quantity	Replacement Cost (£)	Year 1 Repair Cost (£)
Render	Fair	No Action Required	B		10	6 m2	328

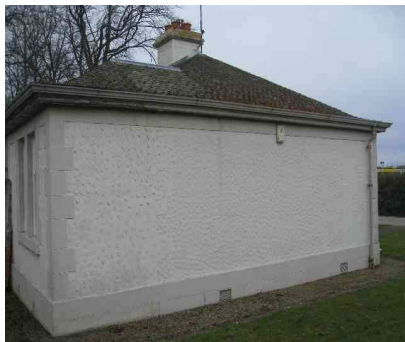
**Photo 1**

<b>Element</b> : External walls		<b>CODE</b> :2					<b>Replacement Cost (£)</b>
<b>Description</b>	<b>Condition</b>	<b>Action</b>	<b>Cond/Ind</b>	<b>Priority</b>	<b>L'Expec</b>	<b>Quantity</b>	
Render	Fair	No Action Required	B		10	17 m2	929
							<b>Year 1 Repair Cost (£)</b>

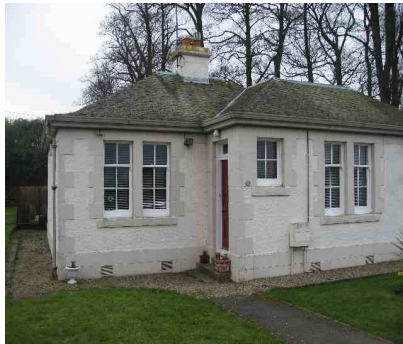
Photo 1

Description	Condition	Action	Cond/Ind	Priority	L'Expec	Quantity	Replacement Cost (£)	Year 1 Repair Cost (£)
Render	Fair	No Action Required	B		10	6 m2	328

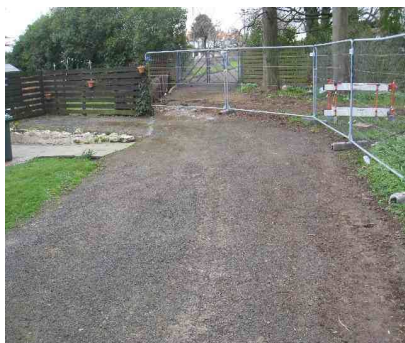
**Photo 1**

Description	Condition	Action	Cond/Ind	Priority	L'Expec	Quantity	Replacement Cost (£)	Year 1 Repair Cost (£)
Tarmacadam roads and parking	Fair	No Action Required	B		10	64 m2	5,249
