Stock Condition Survey 2009

Date: **23rd March 2009**

Reference No: **Edinburgh**
Location:
Whitefoord House

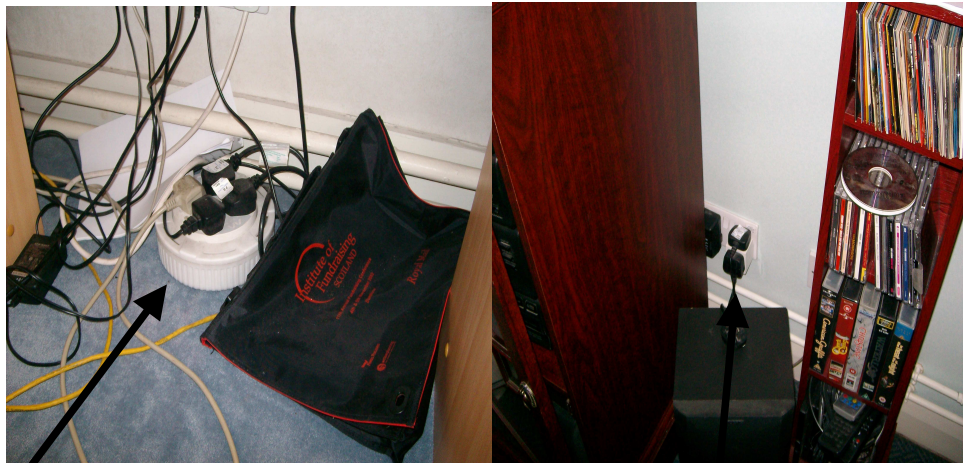
Power distribution was via a mix of Wylex, GET and Dorman Smith DBs located around the bld. Wiring was contained within trunking. This also houses the IT & Telephone system. All were in a fair condition with no defects noted. However there was evidence of extension leads and 3-way adapters in use throughout the bld. This can lead to an overload of the circuits, it is recommended that the use of extensions is reviewed and the removal of 3-way adapters is considered.

Extensions lead in use

3-way adapter in use

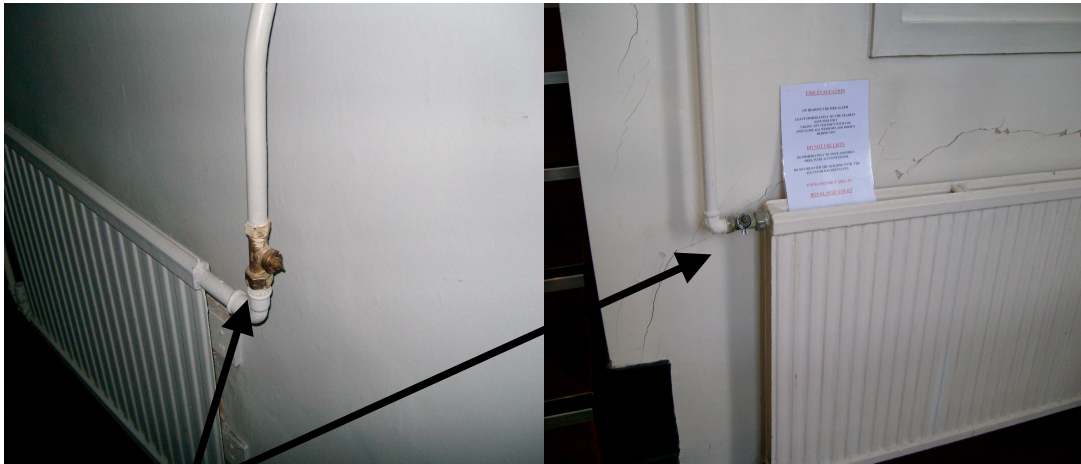
It was noted that throughout the building a number of TRV's are missing from the radiators. It is recommended that they are replaced.

TRV's missing from radiators

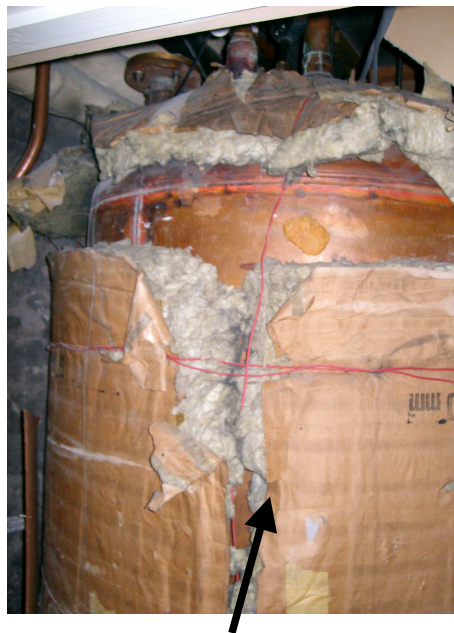
Hot water was provided by the main boilers to a Calorifier, the water was pumped throughout the bld by Grundfos pumps. The condition of the equipment was fair however the Insulation jacket for the Calorifier does not completely cover the Calorifier. It is recommended that this is rectified.

Insulation Jacket requires attention

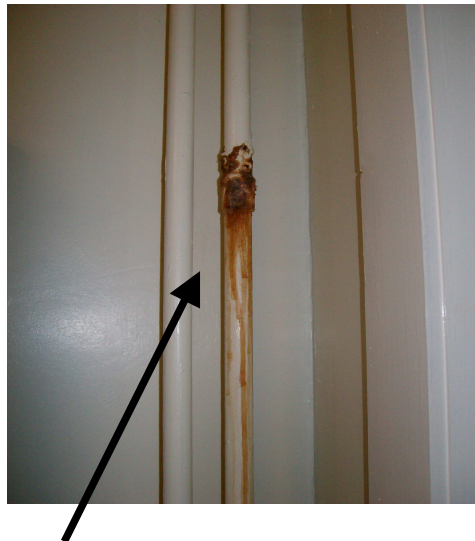
Flat 55 / 2 -- there is evidence of leakage at the bathroom pipework

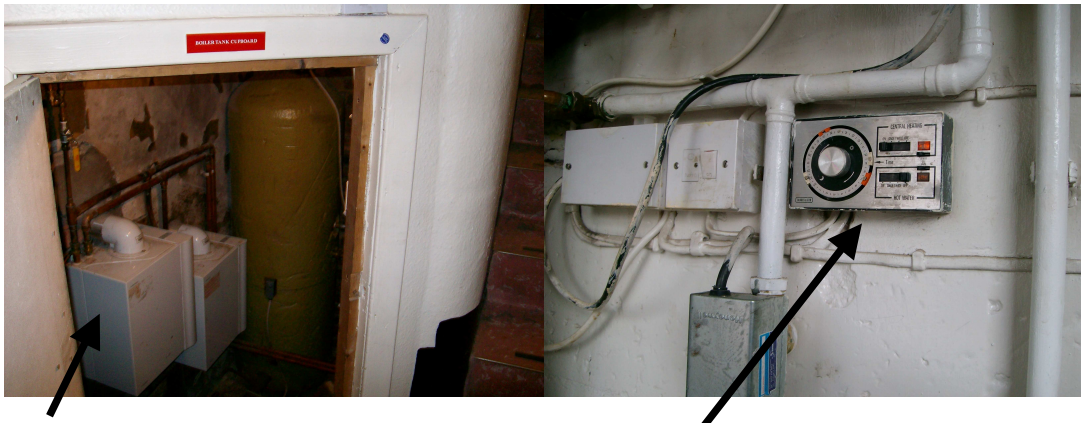
Controls – The controls for the heating system are located within the basement residence of Addison Smith, this is a remote location from the actual heating equipment. It is recommended that the controls are repositioned as access to the controls may not always be available.

Heating equipment under stairs in block

Heating controls within basement residence

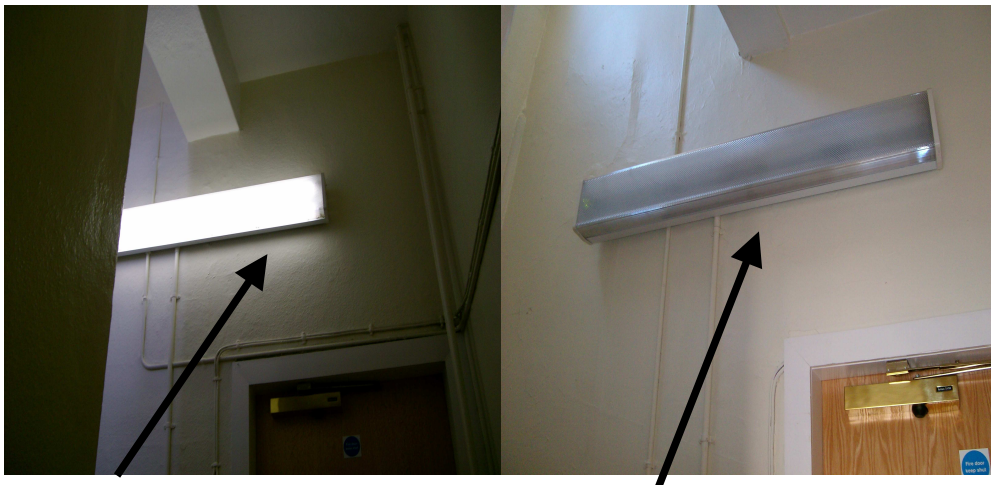
In the main this was a mix of tungsten, CFL and 2D fittings. There was no sign of automatic controls. Within the stairwell T8 lighting was in use. These were controlled by time delay switches however it was noted that none of them operated and all stairwell lights were constantly lit. It is recommended that the lighting controls are rectified. However this survey did not look at system compliance, a further lighting compliance survey would be required. It is recommended that an ongoing maintenance plan is introduced for the replacement of all tungsten lights with CFL lighting; this would help towards reducing the annual electricity costs.

No control over lighting

Flat 55 / 3 states light has never lit

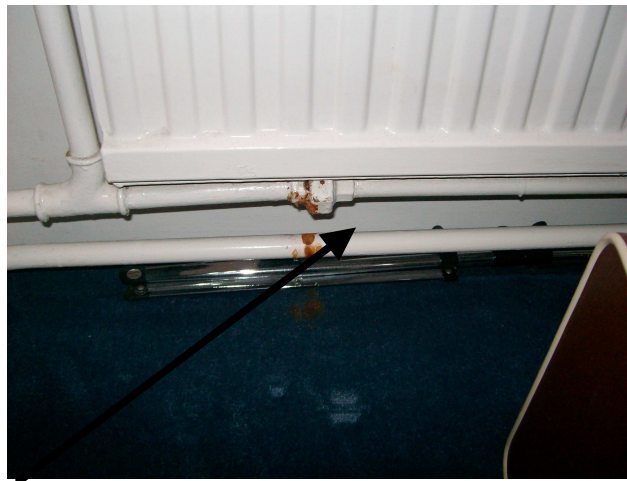
Flat 57/2 -- it was stated that the Living room Radiator has never worked.

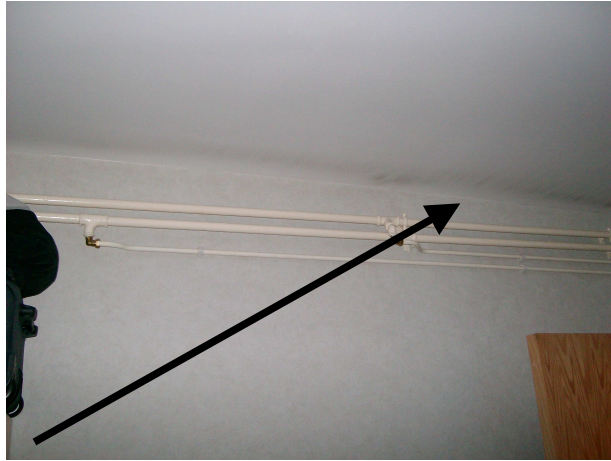
Flat 57/3 -- there is evidence of leakage at the Living room Radiator.

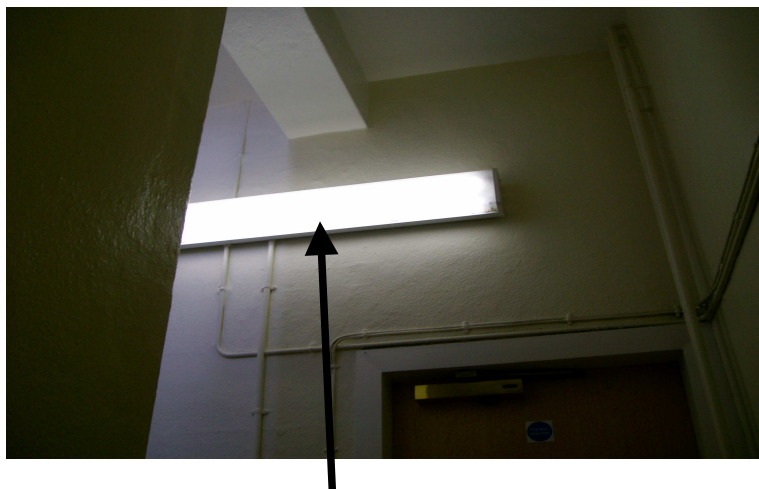
In the main this was a mix of tungsten, CFL and 2D fittings. There was no sign of automatic controls. Within the stairwell T8 lighting was in use. These were controlled by time delay switches however it was noted that none of them operated and all stairwell lights were constantly lit. It is recommended that the lighting controls are rectified. However this survey did not look at system compliance, a further lighting compliance survey would be required. It is recommended that an ongoing maintenance plan is introduced for the replacement of all tungsten lights with CFL lighting; this would help towards reducing the annual electricity costs.

No control over lighting

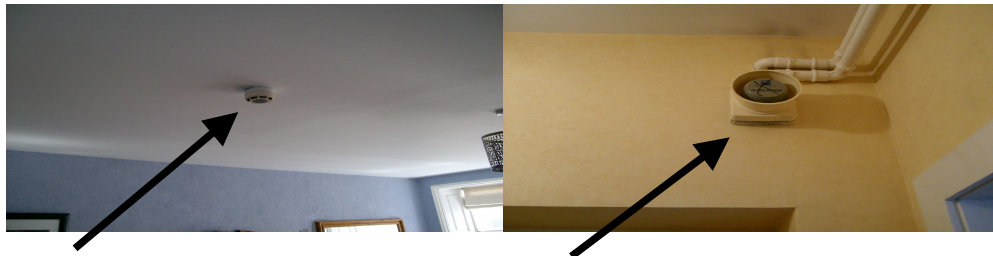
Each residence has been supplied with battery operated stand alone smoke detectors. The condition of these was fair with no defects noted. There are Gent detectors and Sirens installed within the residences, it was stated that these may have been disconnected at the time of refurbishment although it was stated that the sirens still sound when the main building alarm is tested. This survey did not look at system compliance; a further in depth compliance survey would be required.

Detectors not in use

Sirens still connected

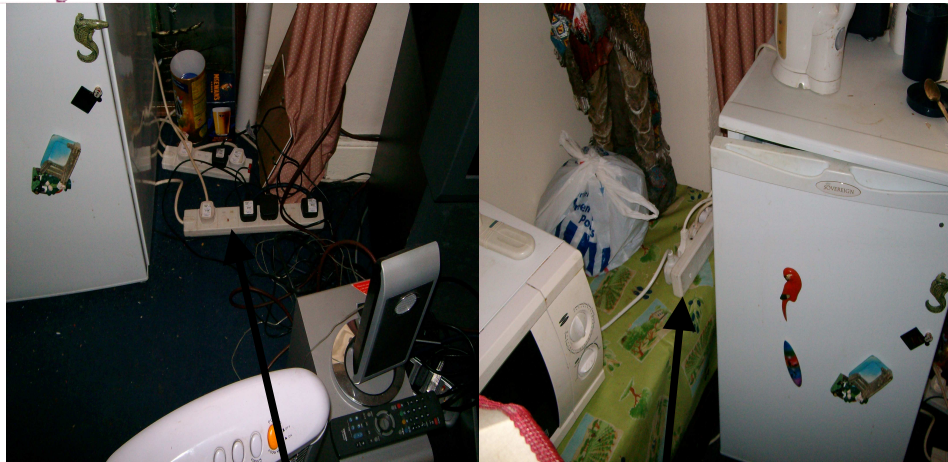
Power distribution was via an MK DB located within the hallway. Wiring was contained within the walls of the bld. All were in a fair condition with no defects noted. However there was evidence of trailing lead extensions in use, this can lead to an overload of the circuit. It is recommended that the use of trailing lead extensions be reviewed.

Extension leads in use

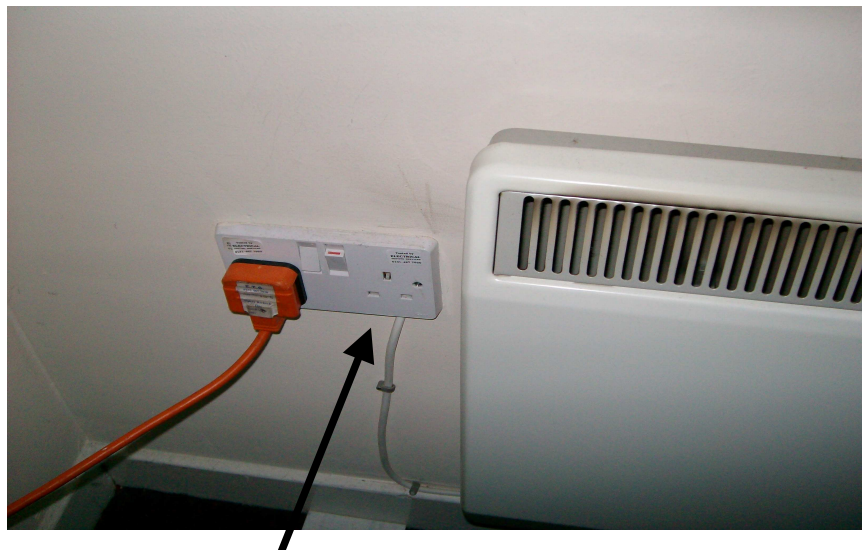
Heating was provided by a number of electric convection heaters. The heating and its associated equipment were in fair condition; however there was evidence of the heaters wired directly to the rear of a socket. BS 7671 states that the heaters should be supplied from a dedicated supply from the DB and not connected to a ring main circuit. It is recommended that the heaters be installed in accordance with BS7671.

Connected to rear of socket

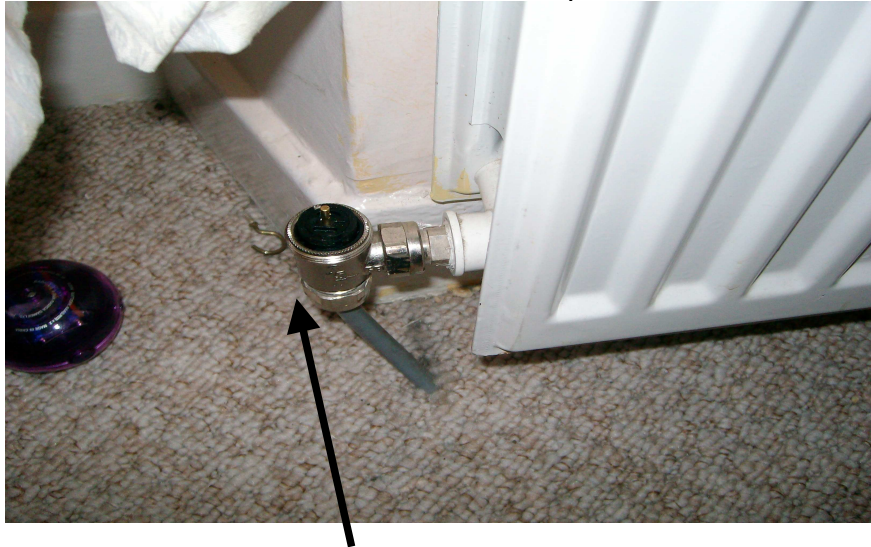
convection radiators. The heating and its associated equipment were in fair condition; however there was evidence of missing TRV within one bedroom. It is recommended that this be replaced.

TRV missing

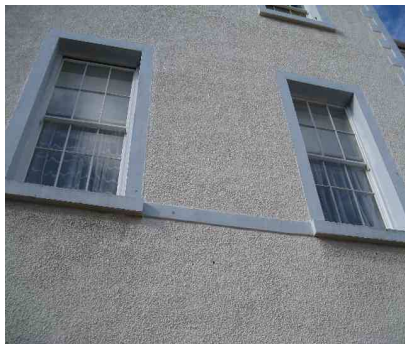
Photo 1

Description	Condition	Action	Cond/Ind	Priority	L'Expec	Quantity	Replacement Cost (£)	Year 1 Repair Cost (£)
Timber softwood sash and case single-glazed windows	Fair, although general overhaul required, including repairs and replacement of missing and snapped sash ropes	Overhaul windows	B	4	10	28 m2	11,483	2,000

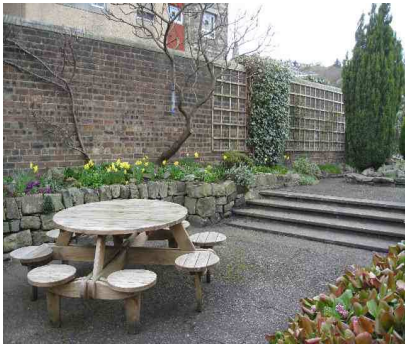
Photo 1

Description	Condition	Action	Cond/Ind	Priority	L'Expec	Quantity	Replacement Cost (£)	Year 1 Repair Cost (£)
Common brick/render with cope	Fair, although render repairs required in areas	Repair damaged areas	B		20	452 m2	43,255

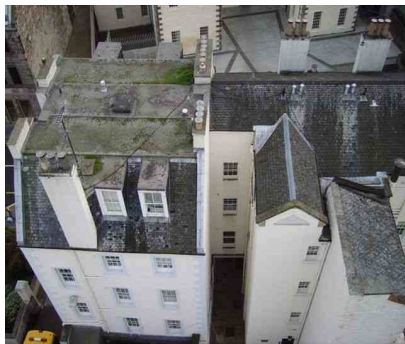
Photo 1

Description	Condition	Action	Cond/Ind	Priority	L'Expec	Quantity	Replacement Cost (£)	Year 1 Repair Cost (£)
Bituminous felt	Poor and reaching end of economic life Signs of vegetation Evidence of some ponding	Clean vegetation off roof Strip off existing cover and replace with high performance felt	C		Replace/In	72 m2	7,382
