BREEAM ECOHOMES LAND USE & ECOLOGY ECO 1 TO ECO 5
ASSESSMENT: CPA 1149 BC 01
JANUARY 2012

NEW BUILD MAINSTREAM & SUPPORTED ACCOMODATION
BELLROCK CRESCENT, GLASGOW

FOR SCOTTISH VETERANS HOUSING ASSOCIATION

BELLROCK CRESCENT, GLASGOW
 SCOTTISH VETERANS HOUSING ASSOCIATION
 NEW BUILD MAINSTREAM & SUPPORTED ACCOMODATION
 BREEAM ECOHOMES LAND USE & ECOLOGY ECO 1 TO ECO 5
 ASSESSMENT: REPORT REFERENCE: CPA 1149 BC 01

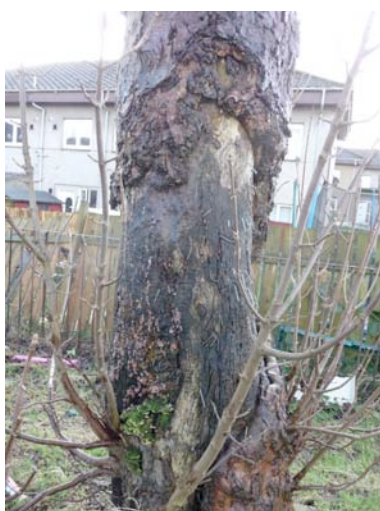
Within the main part of the site, trees are restricted to the east boundary and include a large Sycamore immediately north east of the old school building foundation, a Silver Birch and an ornamental Cherry to the east of the former school building foundation and two Sycamore to the south east of the school building foundation. The Silver Birch has currently non-threatening axe damage approx 1 metre above ground level. The larger of the two Syamores has a very large and old bark wound stretching from the ground level to 1.2m above ground level and greater than 50% of the girth with advanced fungal decay. It is recommended that this tree is removed for public safety reasons. The smaller Sycamore is growing on the boundary fenceline and the main trunk has grown around the fence.

Sycamore with bark wound

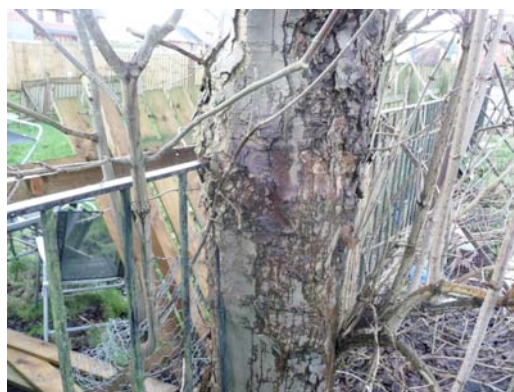
Sycamore growing through fence.

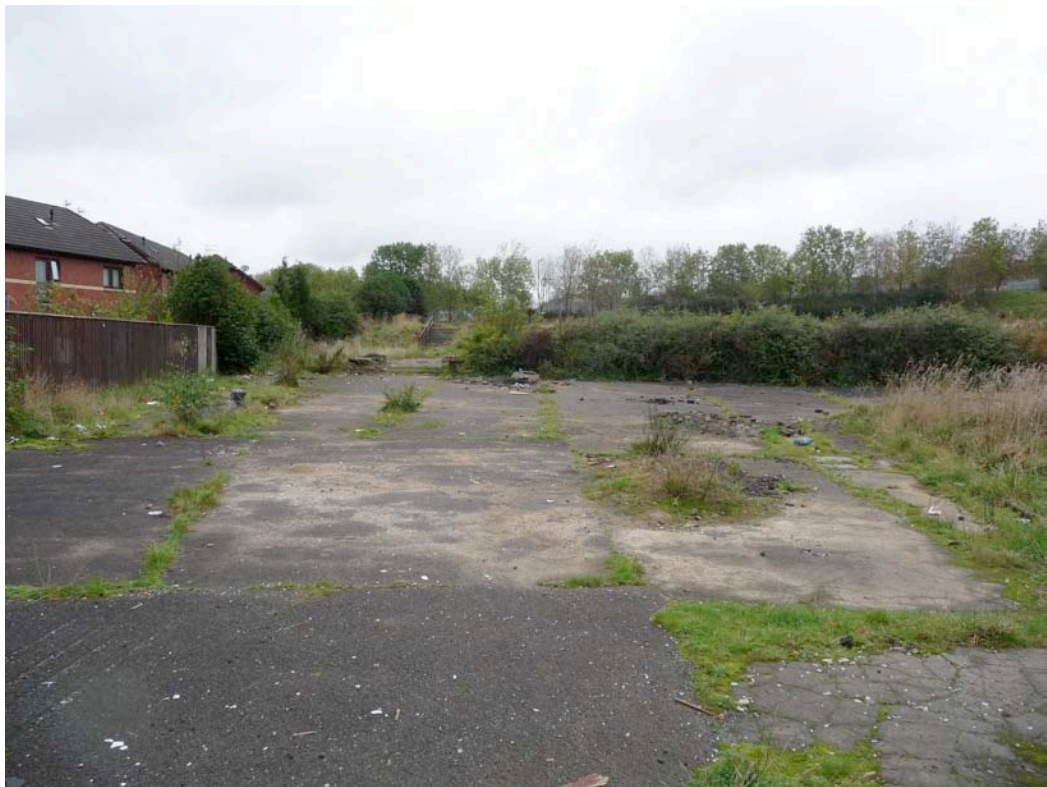
View north along west boundary of the site from the site entrance showing tarmac areas and Escallonia shrubbery below the lower retaining wall dating from the former school site.

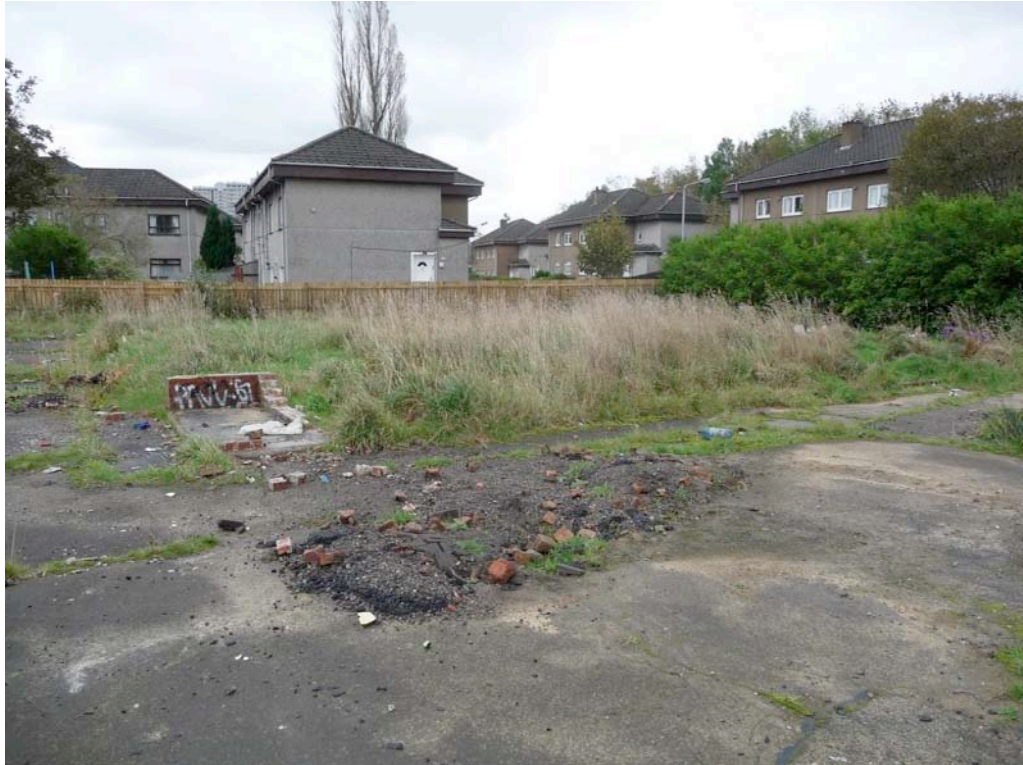
View east along the southern part of site showing mosaic of tarmac, fly tipping and unmaintained grass with the privet hedge on the Bellrock Crescent boundary.

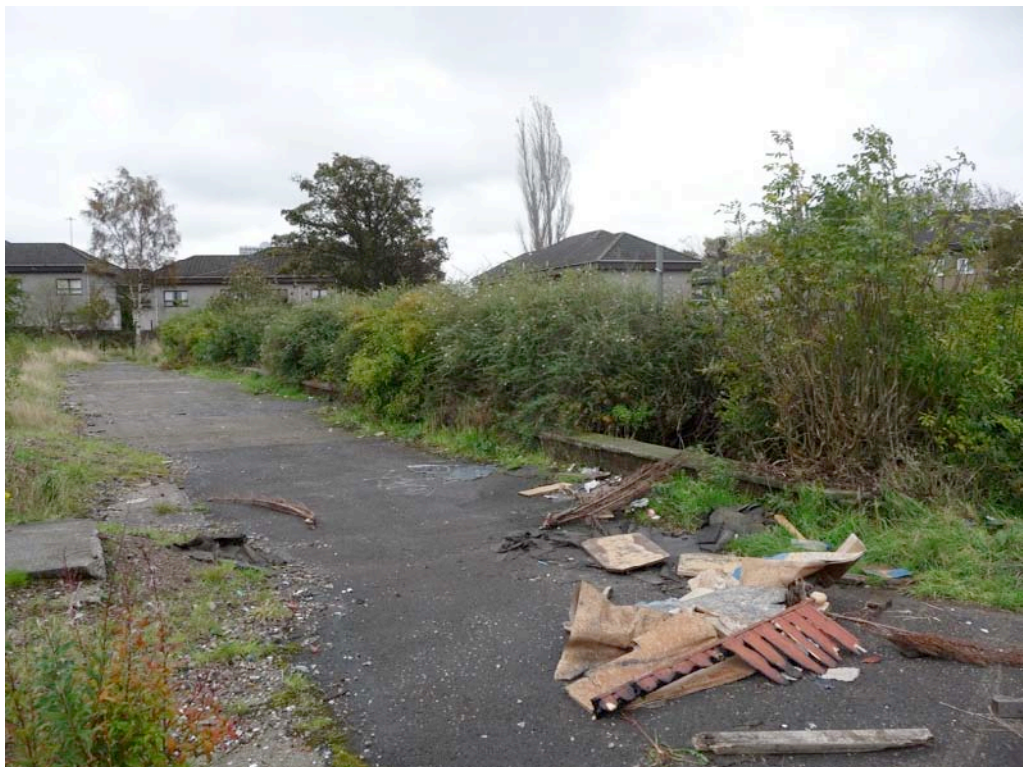
View east along the south edge of the mid-terrace with retaining wall and Escallonia shrubbery on lower side of wall and tarmac path on upper side

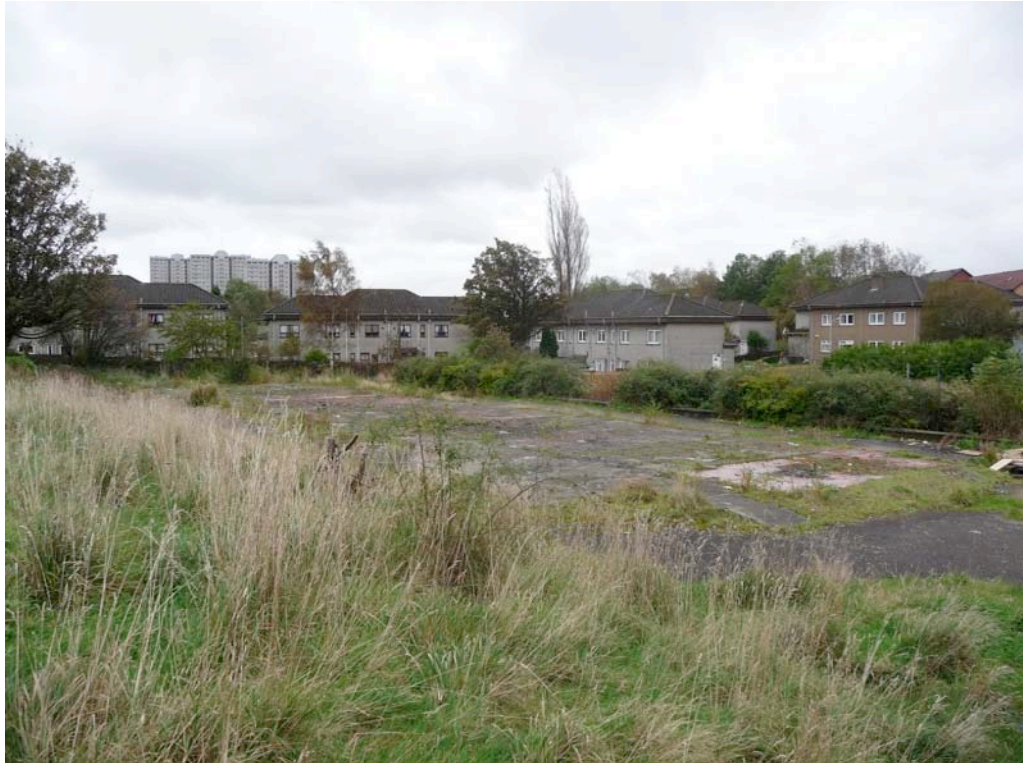
View looking south east over the mid terrace between the grass embankment and lower retaining wall. The foundations of the former school building can be seen in the centre of the photograph.

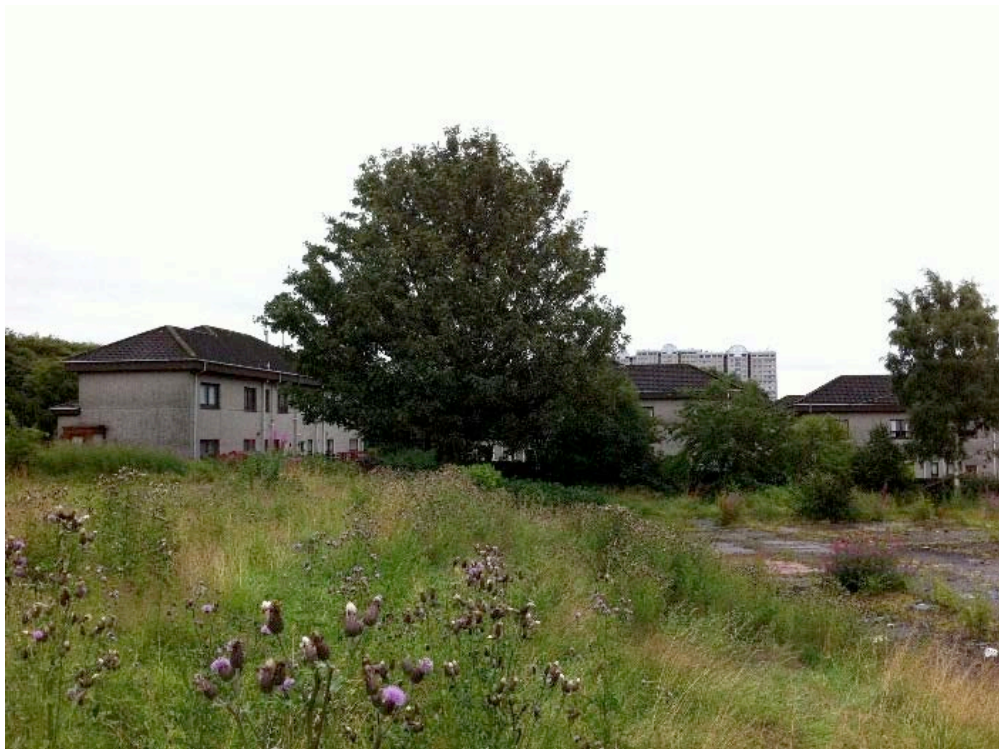
View east along grass embankment between the mid and upper terrace with significant Sycamore tree in background and Cherry and Birch to right. Unmaintained grass embankment being colonised with creeping thistle.

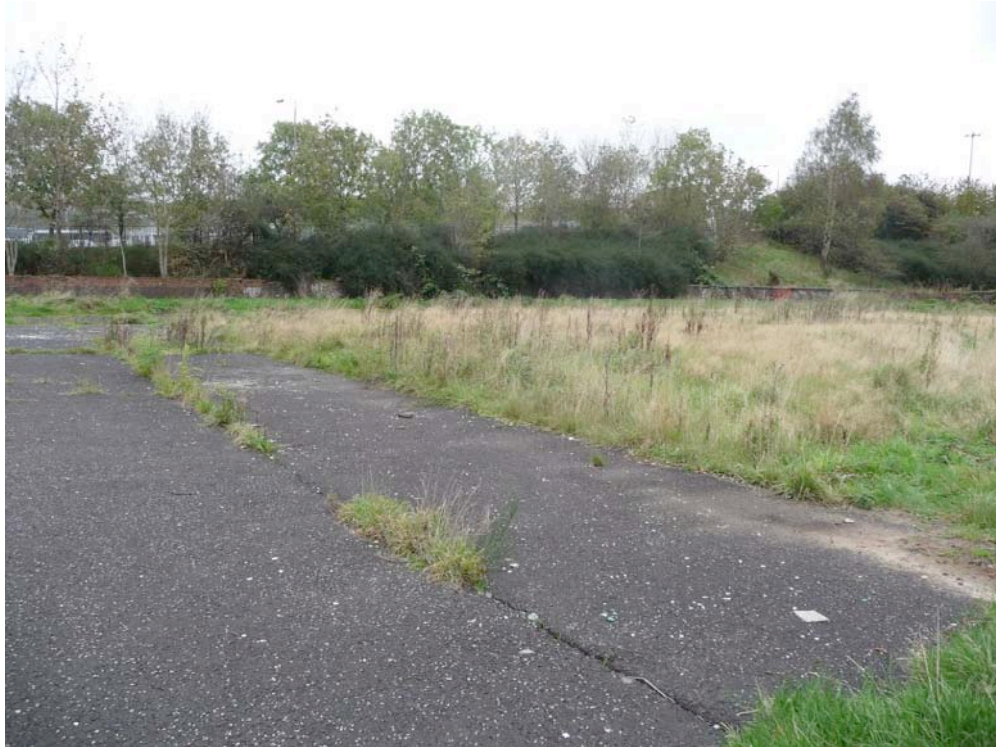
View from upper terrace looking north to the tree planted embankment on north boundary with Gartcraig Road, with mosaic of tarmac and grass in foreground dating from the former school use of the site.

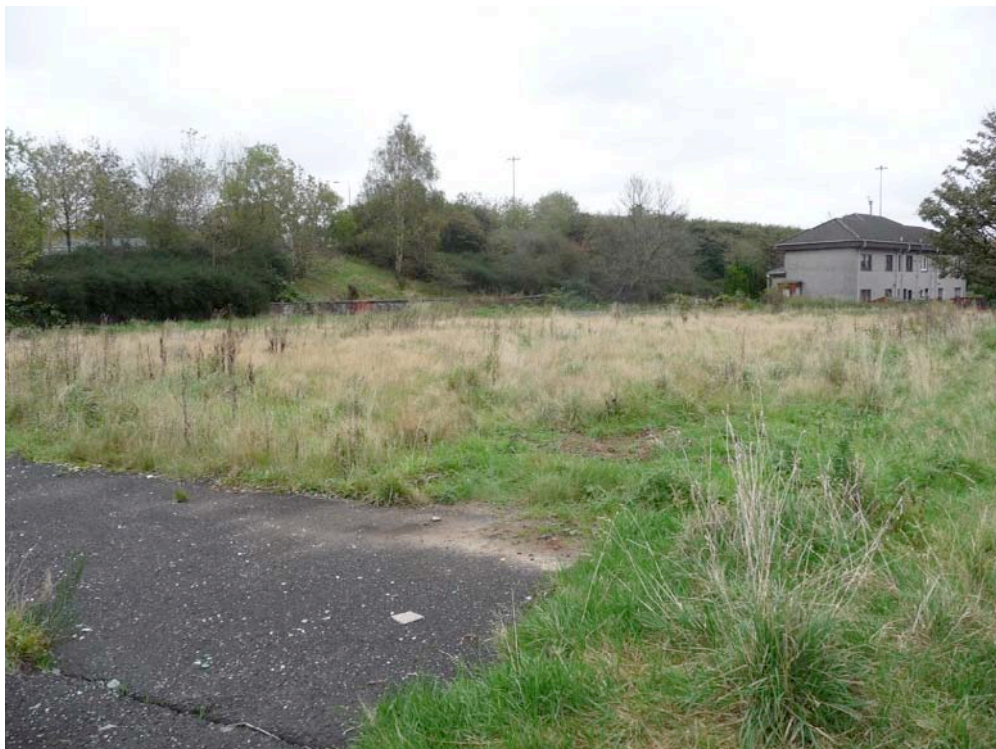
View looking north east across upper terrace of the site to the planted embankment forming the north and north east boundaries and the former school site with tarmac and unmaintained grass in foreground. Note Broad-leaved Dock and Creeping Thistle in the grass areas.

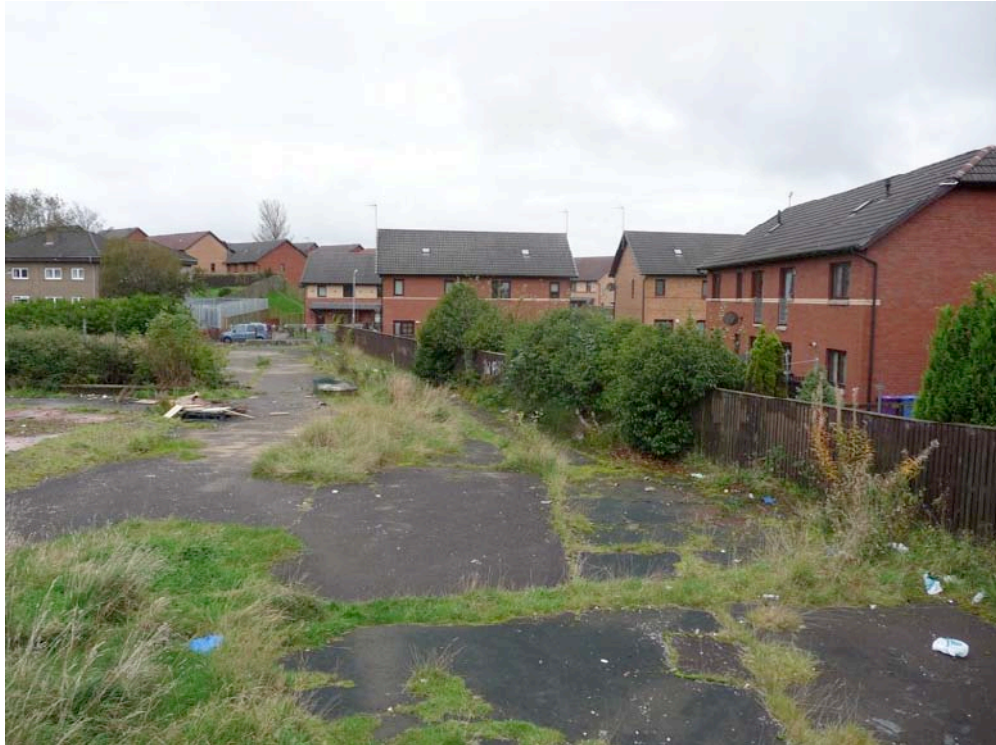
View looking south from upperterrace down the west boundary towards Bellrock Crescent showing a mosaic of tarmac & grass.

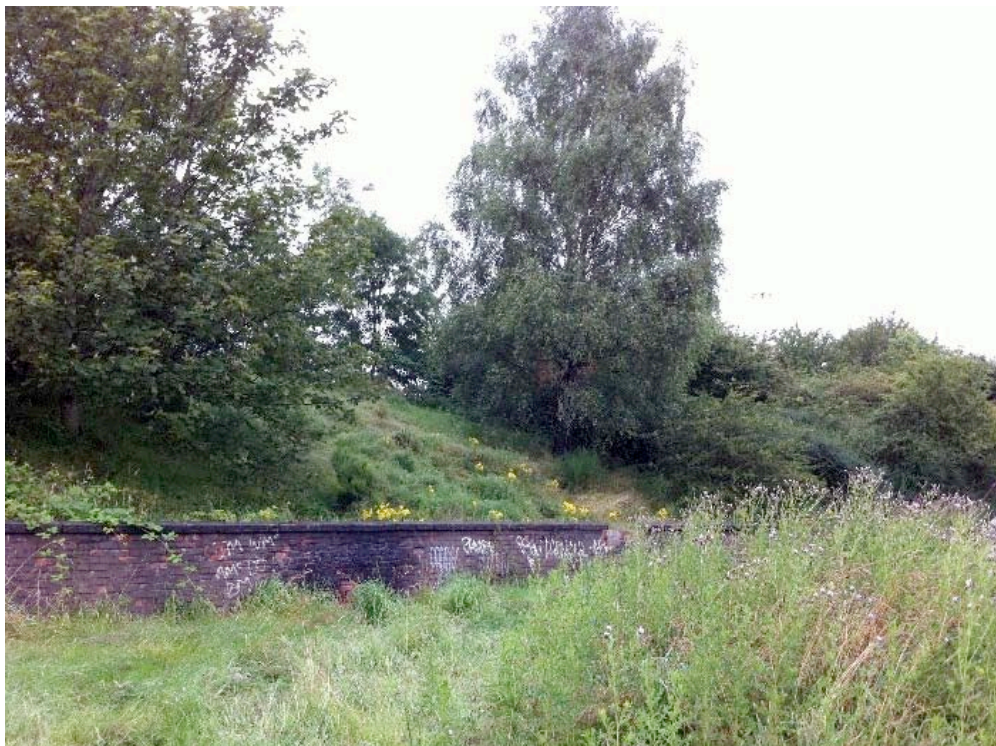
View north east from upper terrace showing north embankment with mixture of grass, Berberis ornamental ground cover shrubs, understory shrubs and trees. Note yellow Ragwort on embankment and Creeping Thistle in foreground.

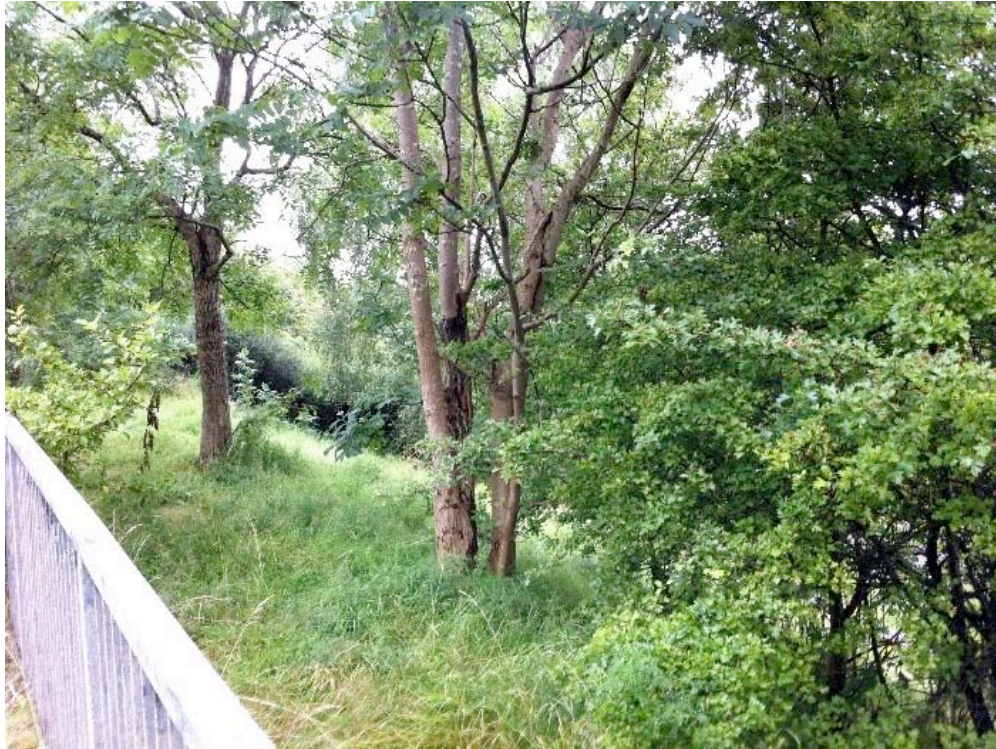
View of north embankment trees viewed from Gartcraig Road footpath. Species include Ash, Sycamore, Hawthorn & Birch.

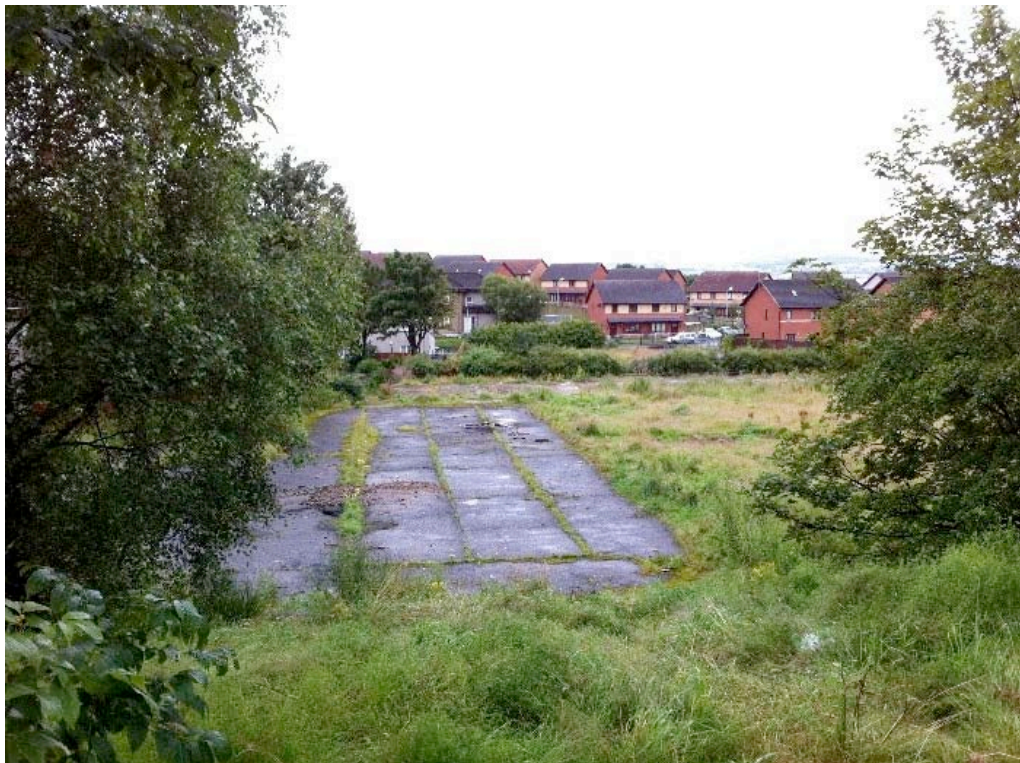
View south from north boundary embankment over mosaic of tarmac hardstandings and unmaintained grass with mid terrace shrubs and south boundary privet hedge in the background

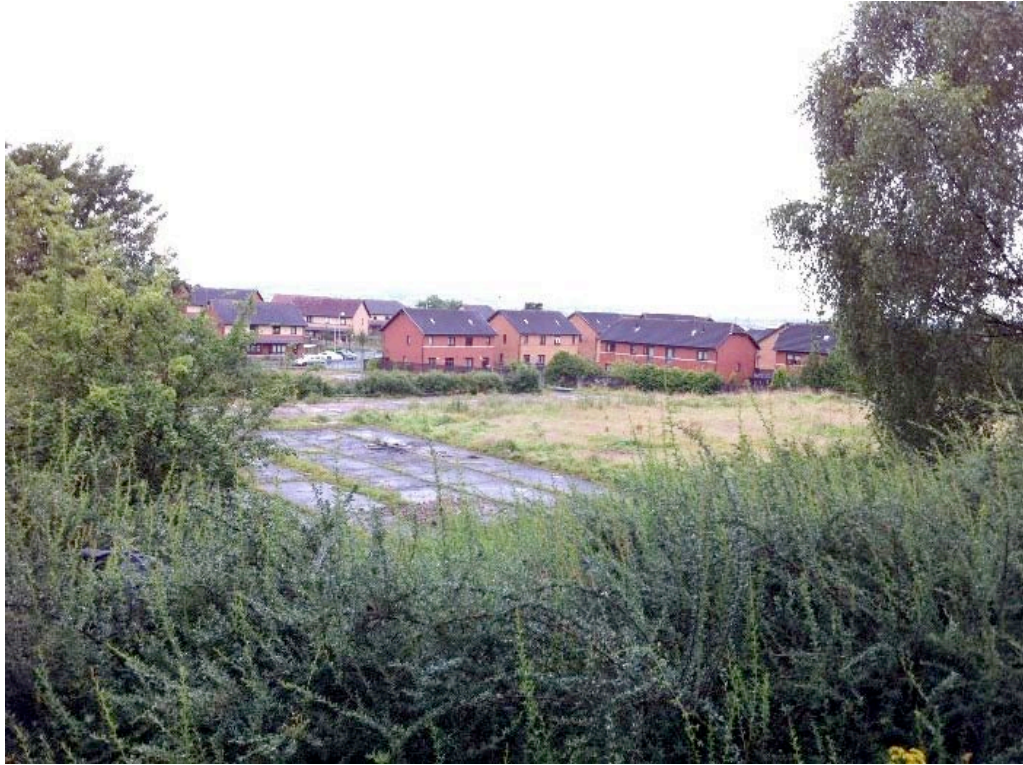
View south west from north boundary embankment showing Berberis ground cover shrubs and birch tree with upper terrace and neighbouring housing behind.

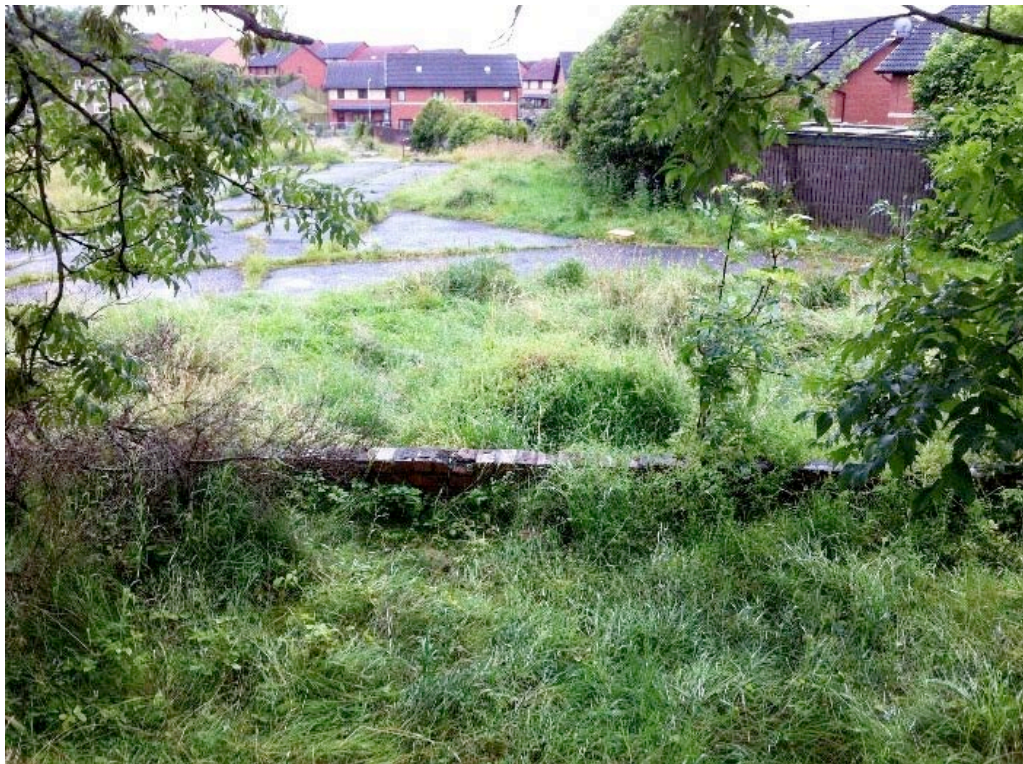
View from north west corner of north boundary embankment showing top of retaining wall and mosaic of unmaintained hard and soft landscape surface of former school site.
