Client: SCOTTISH VETERANS HOUSING ASSOCIATION  
Project: NEW BUILD MAINSTREAM AND SUPPORTED ACCOMMODATION BELLROCK CRESCENT ECOLOGICAL SURVEY  
Title: Drg no: C1149.001  
Date: JAN 2012  
Drawn: CP  
Scale: 1:500 @ A1

CHRISTOPHER PALMER ASSOCIATES  
Landscape Architects

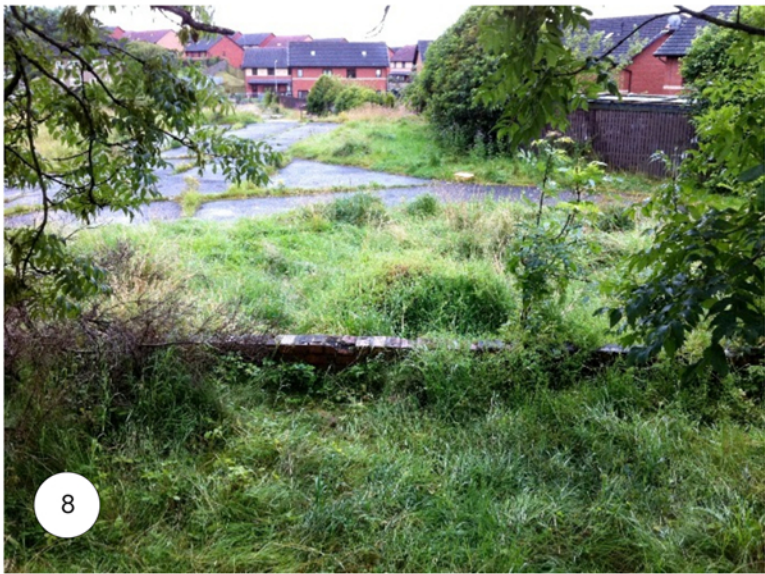
View from north west corner of north boundary embankment showing top of retaining wall and mosaic of unmaintained hard and soft landscape surface of former school site.

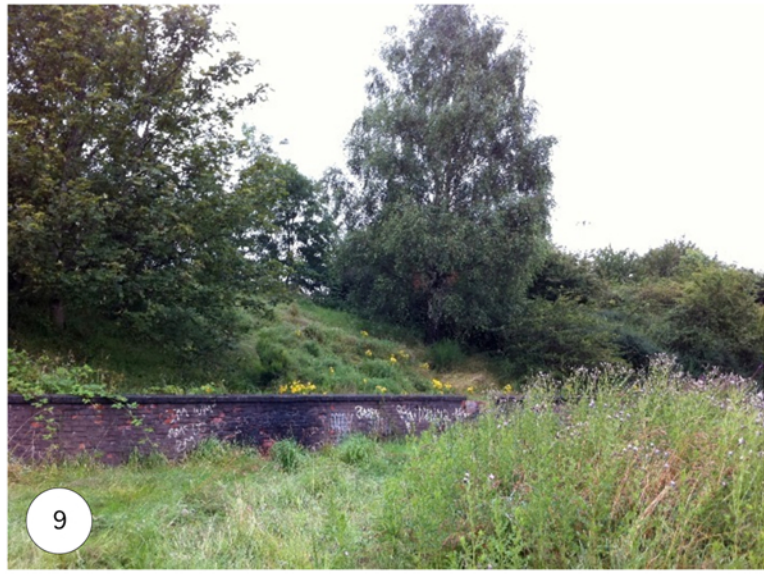
View north east from upper terrace showing north embankment with mixture of grass, Berberis ornamental ground cover shrubs, understorey shrubs and trees. Note yellow Ragwort on embankment and creeping thistle in foreground.

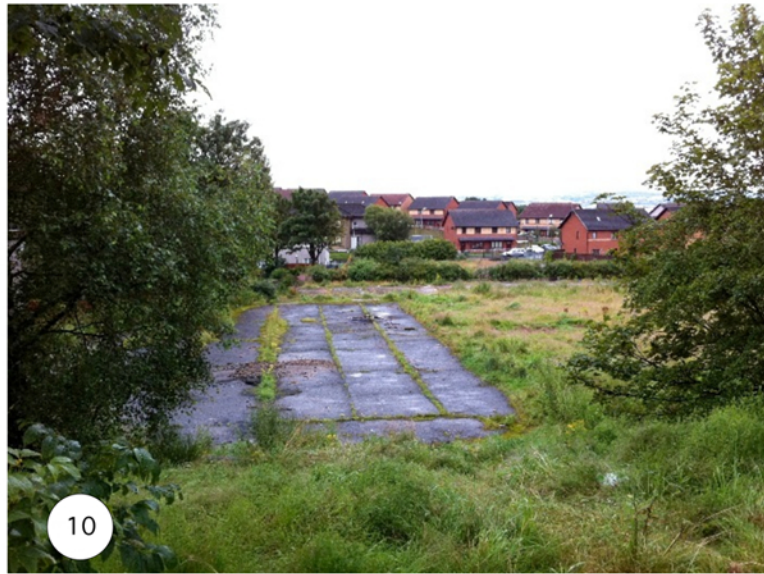
View south from north boundary embankment over mosaic of tarmac hardstandings and unmaintained grass with mid terrace shrubs and south boundary privet hedge in the background

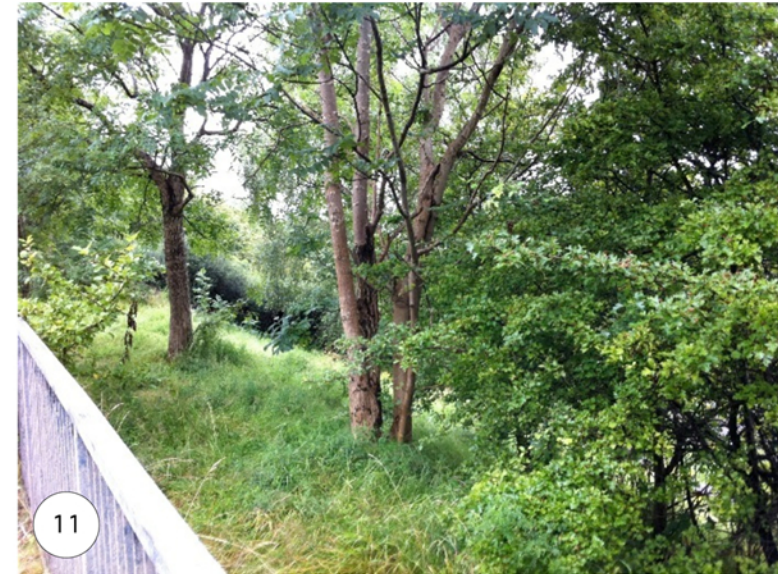
View of north embankment trees viewed from Gartcraig Road footpath. Species include Ash, Sycamore, Hawthorn & Birch.

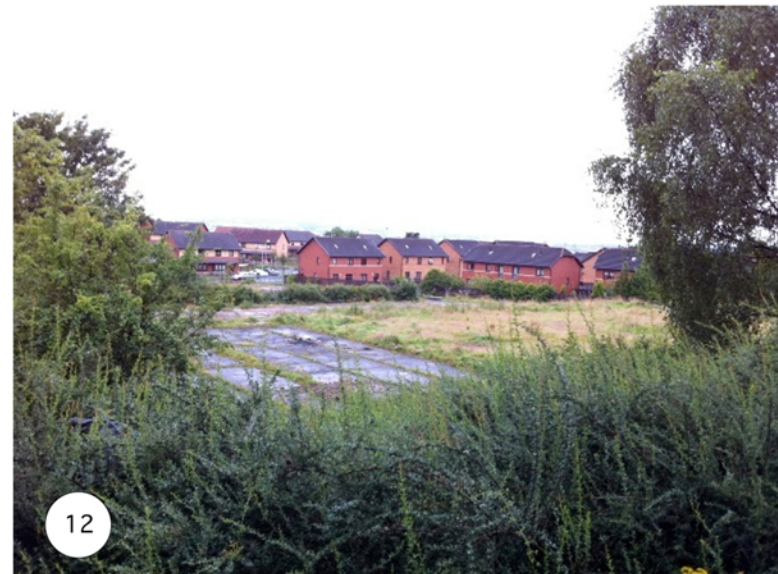
View south west from north boundary embankment showing Berberis ground cover shrubs and birch tree with upper terrace and neighbouring housing behind.

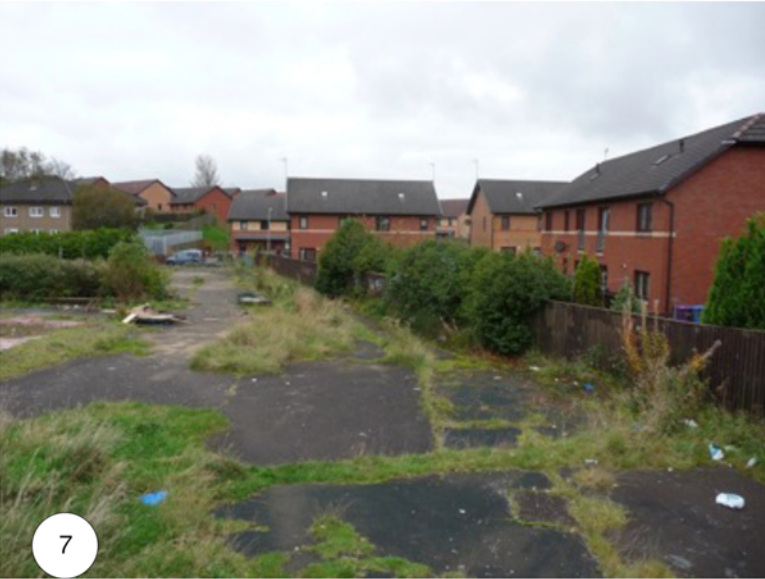
View looking south from upper terrace down the west boundary towards Bellrock Crescent showing a mosaic of tarmac & grass.

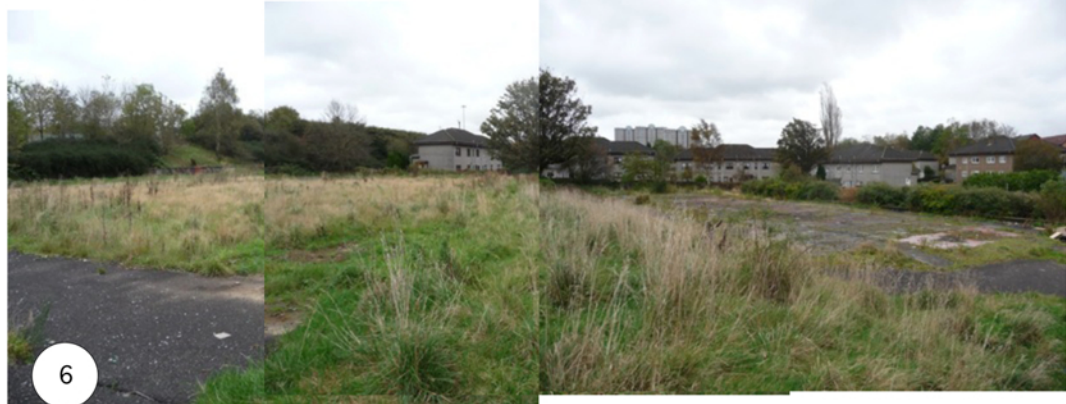
View from upper terrace looking north to the tree planted embankment on north boundary with Gartcraig Road, with mosaic of tarmac and grass in foreground dating from the former school use of the site.

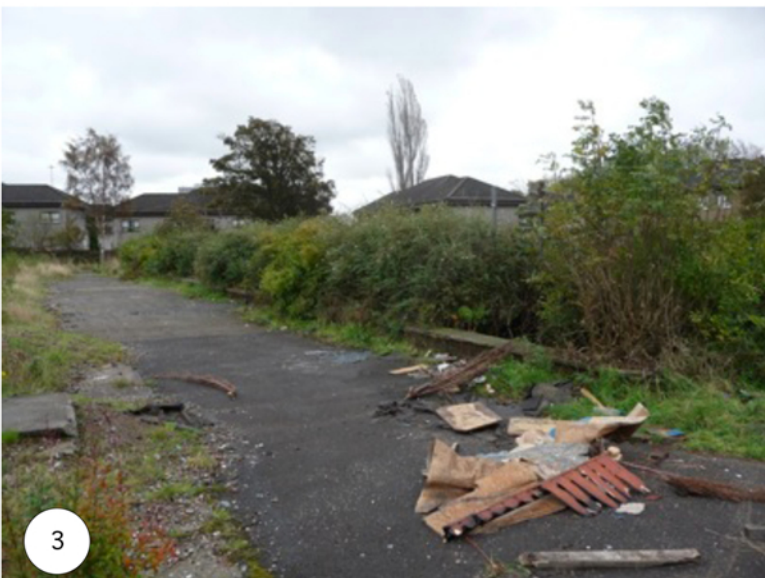
View east along the south edge of the mid-terrace with retaining wall and Escallonia shrubbery on lower side of wall and tarmac path on upper side

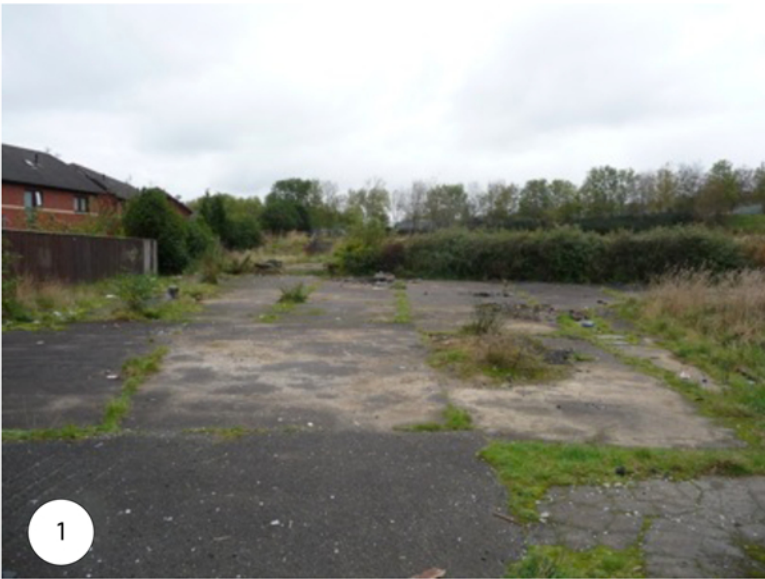
View north along west boundary of the site from the site entrance showing tarmac areas and Escallonia shrubbery below the lower retaining wall dating from the former school site.

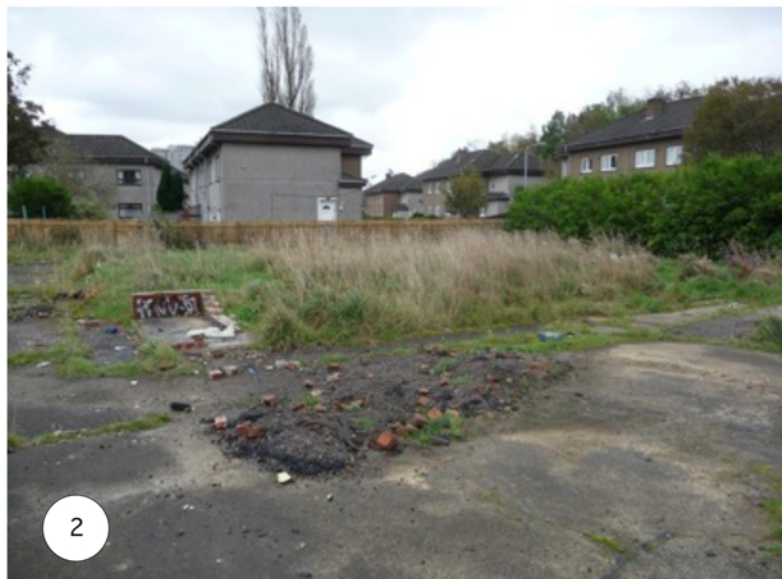
View east along the southern boundary of site showing mosaic of tarmac, fly tipping and unmaintained grass with the privet hedge on the Bellrock Crescent boundary. The privet hedge has subsequently been trimmed back to 1.8m height.

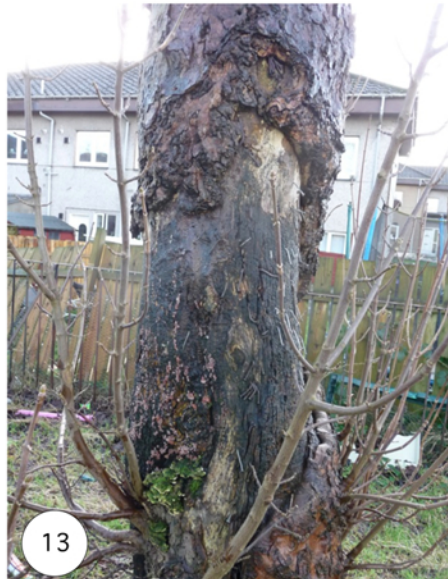
Sycamore with bark wound. It is recommended that this tree be felled for public safety reasons due to extensive decay and weakening of structure.

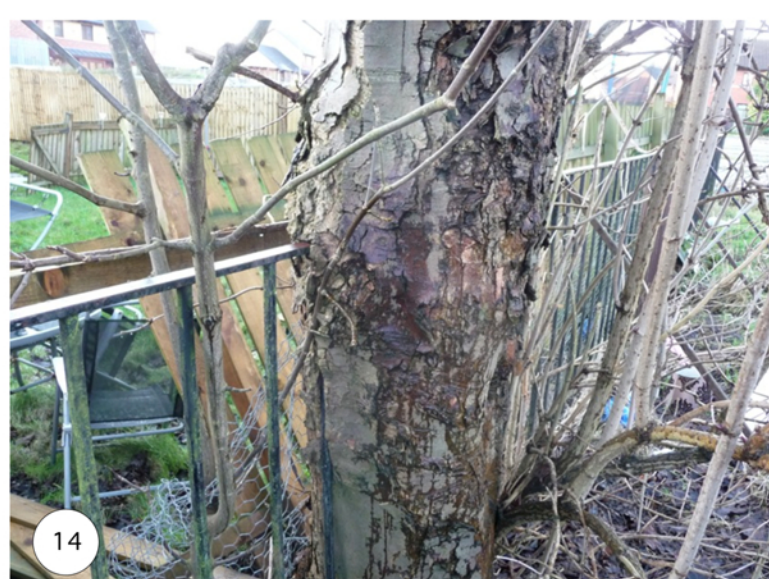
Sycamore growing into fence on south boundary.

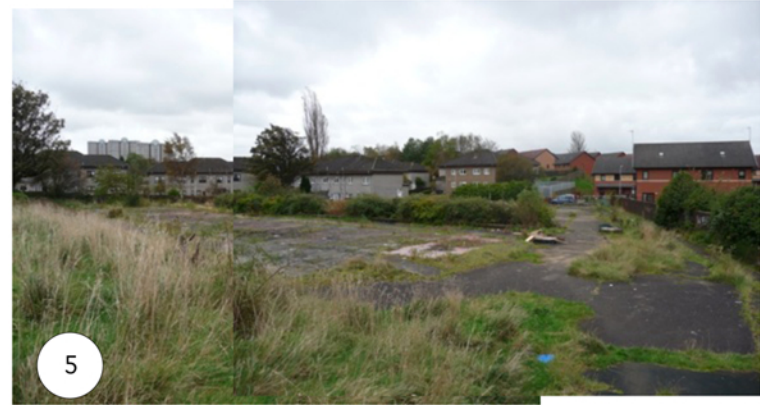
View looking south east from the north west corner of the mid terrace. The foundations of the former school building can be seen in the centre of the photograph.

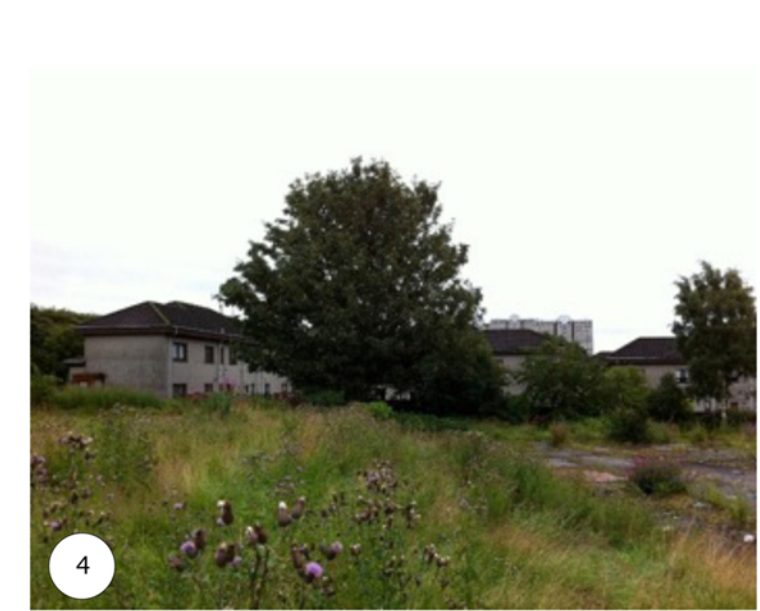
View looking east from the west end of the grass embankment. Colonising Creeping Thistle on unmaintained grass. Large Sycamore, Cherry and Birch on east boundary. The foundations of the former school building with colonising weed growth, broom & birch can be seen in the right of the photograph.

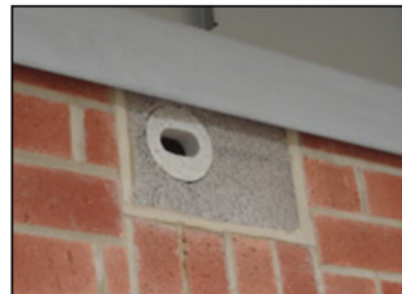
Potential for swift boxes built into building facades under eaves.

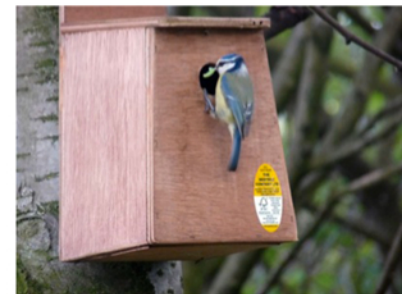
Potential for bird boxes fixed to existing trees
