Stock Condition Survey 2009

Carried Out By: Richard Robertson, Antony Duffy and Owen Holleway Reference No: **Dundee** Location: **Rosendael**

Date: 30th March 2009

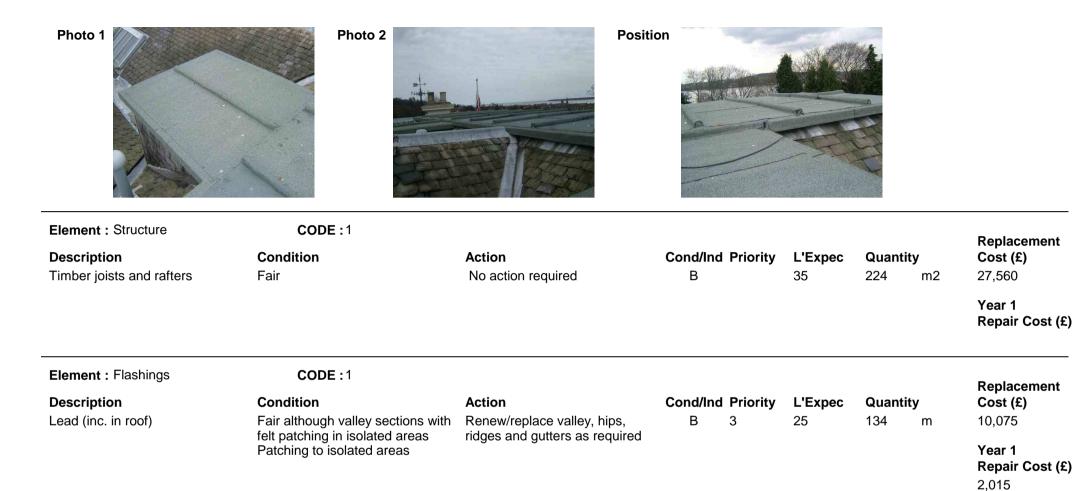
BUILDING : Block 01 Kyd	UPRN :		R : Roof			
ROOM : Roof001	No : 002/1	/R/001 US	E:			
Element : Covering	CODE:1					Replacement
Description Natural slate	Condition Fair with several slipped ,cra	Action cked Repair/Replace missing,cra	Cond/Ind Priority cked B 3	L'Expec 25	Quantity 224 m2	Cost (£) 41,341
	and missing slates	and slipped slates				Year 1 Repair Cost (# 500
Photo 1	Photo 2		osition			Replacement
Description Mineral felt	Condition	Action	Cond/Ind Priority	L'Expec	Quantity	Cost (£)
Description Mineral felt	Fair	No action required	В	15	37 m2	3,034

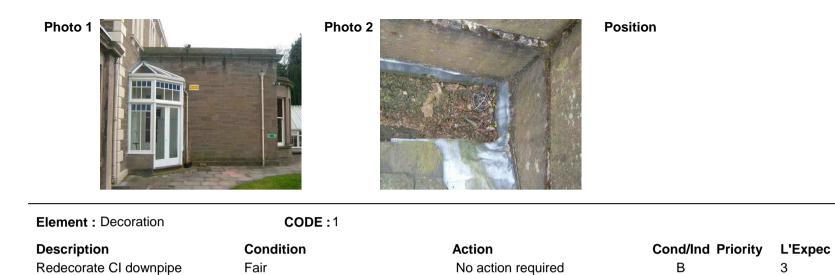
Description	Condition	Action	Cond/Ind Priority	L'Expec	Quan	tity	Cost (£)	·
Cast iron downpipe Cast iron outlet box	Fair but with choked outlet	Clean out choked gutters	В	15	4	m	273	
							Year 1

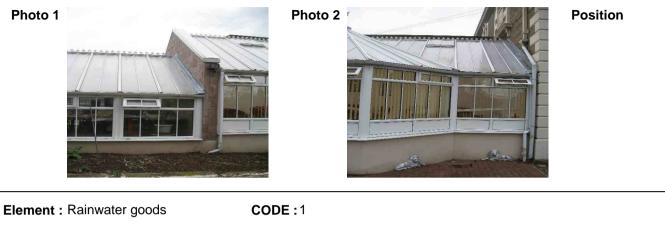
BUILDING : Block 06 Greenhou	ISE UPRN :	F	LOOR : Roof			
ROOM : Roof	No : 00	2/6/R/001	USE :			
Element : Covering	CODE : 1					Replacement
Description PVC-u glazed roof sections	Condition Fair	Action No action required	Cond/Ind Priority B	L'Expec 20	Quantity 132	Cost (£) 20,000
						Year 1 Repair Cost (£
Photo 1	Photo 2		Position			
Element : Structure	CODE : 1					Denlessment
Description Metal frame	Condition Fair	Action No action required	Cond/Ind Priority B	L'Expec 40	Quantity 1 m2	Replacement Cost (£) 170
						Year 1 Repair Cost (£
Element : Flashings	CODE : 1					Replacement
Description Lead (inc. in roof)	Condition Fair	Action No action required	Cond/Ind Priority B	L'Expec 50	Quantity 12 m	Cost (£) 902
						Year 1

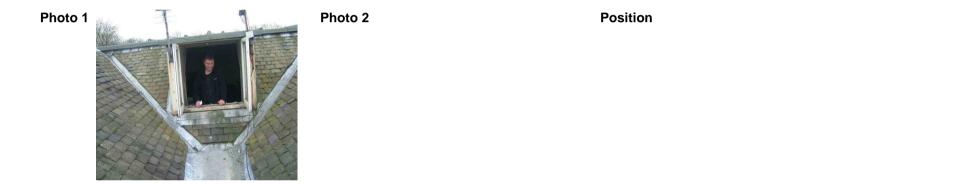
BUILDING : Block 01 Kyd	UPRN :		FLOOR : R	oof				
ROOM : Roof001	No : 002/1/R/0	01	USE :					
Element : Windows Description 2 No.Timber softwood casement	CODE :2 Condition Fair but at end of economic life	Action No Action Required		Cond/Ind Priority B	L'Expec 5	Quant 4	ity m2	Replacement Cost (£) 1,640
single glazed								Year 1 Repair Cost (£)

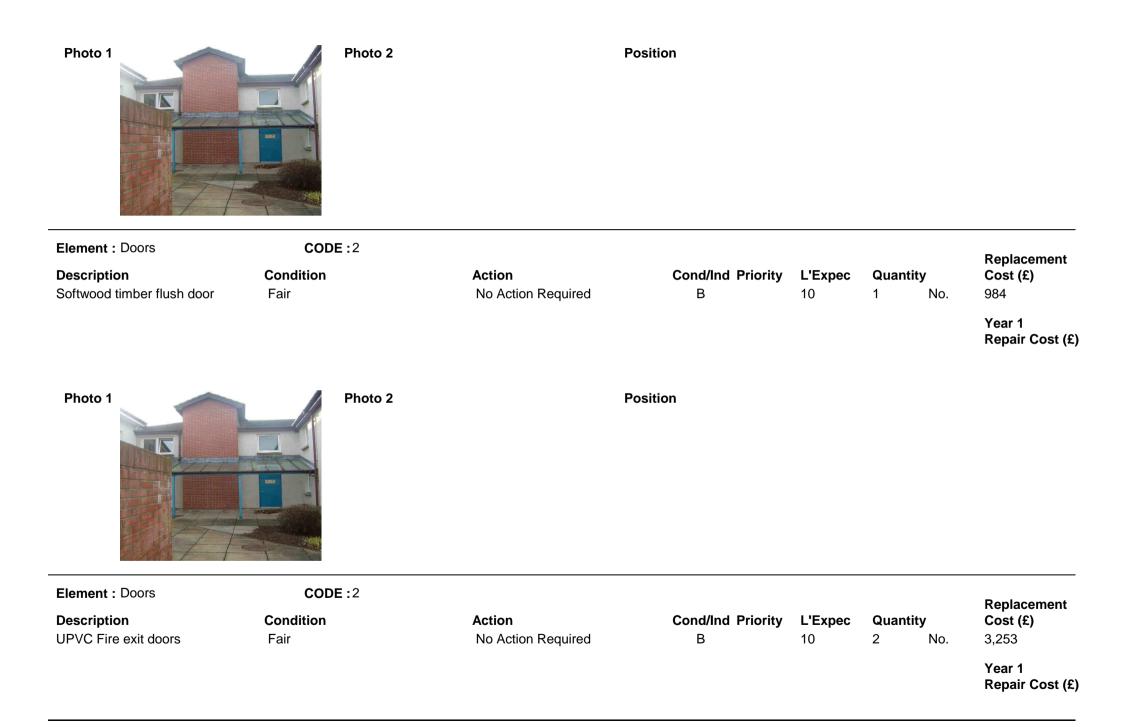
BUILDING : Block 04 Keays	UPRN :	F	LOOR : Elevations			
ROOM : Elevation001	No : 002/4/E	E/001	USE :			
Element : External walls Description Facing brick	CODE : 2 Condition Fair	Action No Action Required	Cond/Ind Priority B	L'Expec 31	Quantity 13 m2	Replacement Cost (£) 1,332
						Year 1 Repair Cost (
Photo 1	Photo 2		Position			
Element : External walls	CODE : 2					
Description	Condition	Action	Cond/Ind Priority	L'Expec	Quantity	Replacement Cost (£)
Dry dash	Fair	No Action Required	В	16	15 m2	820
						Year 1 Repair Cost (/
Element : Windows	CODE:2					Replacement
Description 2 No. PVC-u tilt and turn double	Condition Fair	Action No Action Required	Cond/Ind Priority B	L'Expec 11	Quantity 3 m2	Cost (£) 2,255
glazed						Voor 1

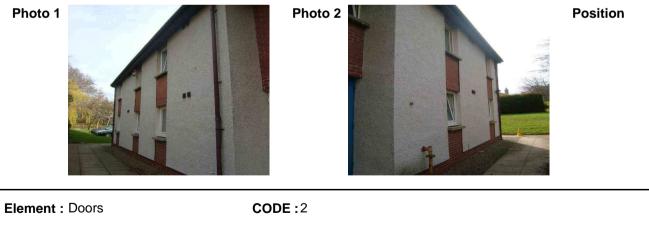
Element : Windows	CODE : 2						Replacement
Description	Condition	Action	Cond/Ind Priority	L'Expec	Quan	tity	Cost (£)
12 No. PVC-u tilt and turn double	Fair	No Action Required	В	11	13	m2	9,774
glazed							Year 1
							Repair Cost (£)

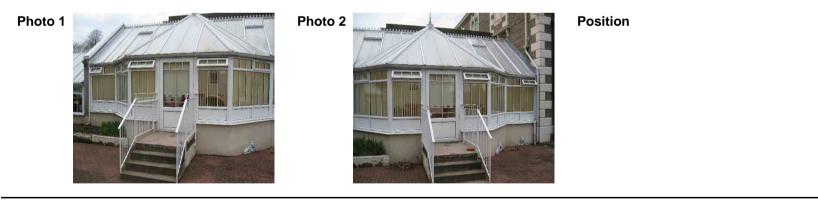
BUILDING : Block 06 Greenhous	e UPRN :	:	FLOOR : E	levations				
ROOM : Elevation	No :	: 002/6/E/001	USE :					
Element : External walls Description Render finish	CODE : 2 Condition Fair	Action No Action Red	quired	Cond/Ind Priority B	L'Expec 25	Quantit 6	y m2	Replacement Cost (£) 328
								Year 1 Repair Cost (£)
Element : Windows	CODE:2							Replacement
Description	Condition	Action		Cond/Ind Priority	L'Expec	Quantit	у	Cost (£)
PVC-u casement double-glazed window sections	Fair	No Action Red	quired	В	20	9	m2	6,767
								Year 1 Repair Cost (£)

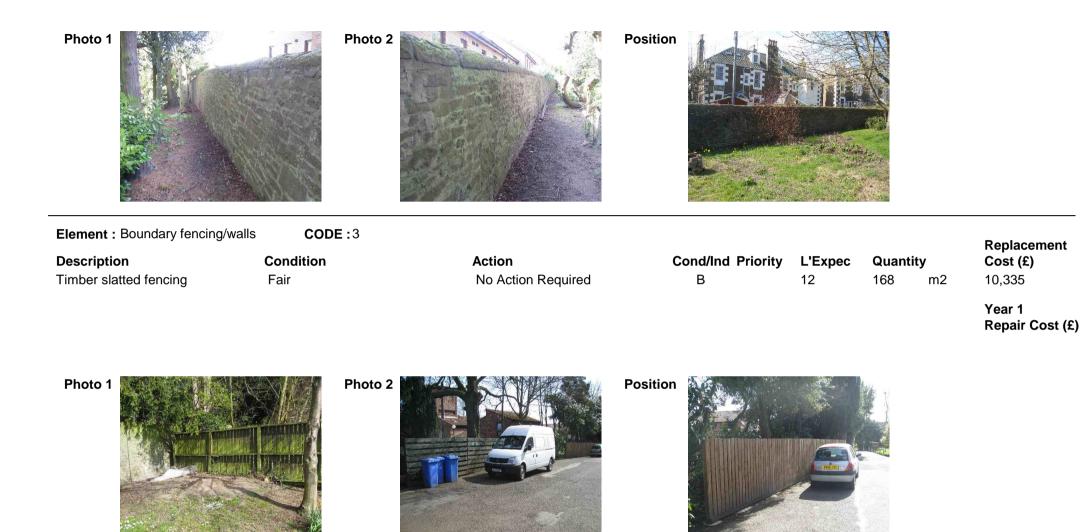
Element : Steps/ramps Description Concrete steps/ramps	CODE : 3 Condition Fair	Action No Action Required	Cond/Ind Priority B	L'Expec 35	Quantity 24 m2	Replacement Cost (£) 4,921 Year 1 Repair Cost (£
Photo 1	Photo 2		Position			
Element : Handrails	CODE:3					Replacement
Description Metal handrails	Condition Fair	Action No Action Required	Cond/Ind Priority B	L'Expec 20	Quantity 18 m	Cost (£) 1,230
						Year 1 Repair Cost (£
Element : Boundary fencing/walls	s CODE:3					Replacement
Description	Condition	Action	Cond/Ind Priority	L'Expec	Quantity	Cost (£)
Stone boundary wall	Fair	No Action Required	В	20	424 m2	11,593
Note: Cost relates to re-pointing						Year 1 Repair Cost (f

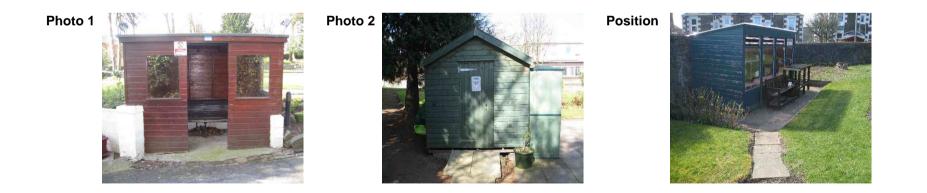
Element : Outdoor Sports Facil Fixed Furniture	ities / CODE:3					Replacement
Description	Condition	Action	Cond/Ind Priority	L'Expec	Quantity	Cost (£)
1 no. timber shelter	Fair	No action required	В	10	4	10,000
2 no. timber huts						Year 1 Repair Cost (£)
1 no. gardners hut						Repair Cost (£)
