Stock Condition Survey 2009

Date: **23rd March 2009**

Reference No: **Edinburgh**
Location:
Whitefoord House

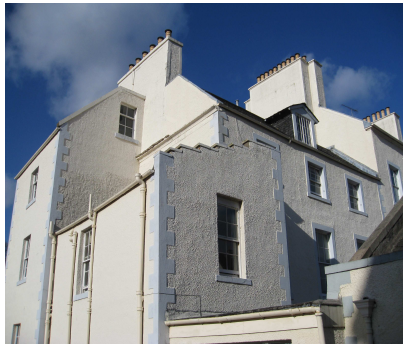
**Year 1
Repair Cost (£)****Photo 1**

**Photo 2****Position****Element** : Windows**CODE** :2**Description****Condition****Action****Cond/Ind Priority****L'Expec****Quantity****Replacement
Cost (£)**7 No. Timber sash and case
single glazed (2m2)

Fair but requires repainting

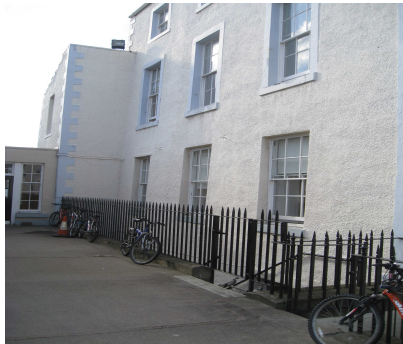
**Year 1
Repair Cost (£)****Photo 1**

**Photo 2****Position****Element** : External walls**CODE** :2**Description****Condition****Action****Cond/Ind****Priority****L'Expec****Quantity****Replacement
Cost (£)**Window surrounds :cills,lintols
and jambs

Fair

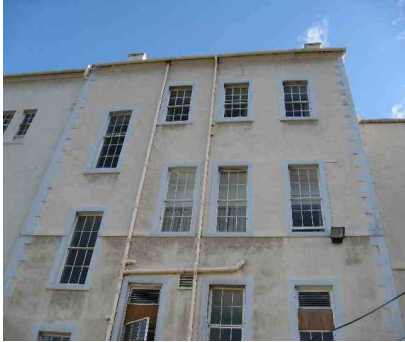
Photo 1

Description	Condition	Action	Cond/Ind	Priority	L'Expec	Quantity	Replacement Cost (£)	Year 1 Repair Cost (£)
Cast iron gutters and downpipes	Fair	No action required	B		10	90 m	6,151

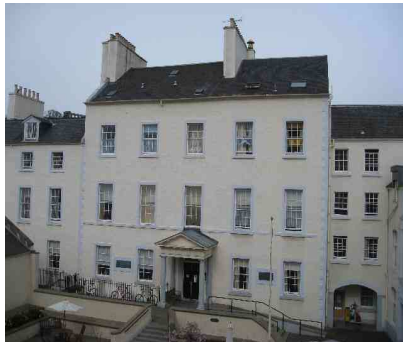
Photo 1

Description	Condition	Action	Cond/Ind	Priority	L'Expec	Quantity	Replacement Cost (£)	Year 1 Repair Cost (£)
Render finish (wet-dash)	Fair	No Action Required	B		10	179 m2	12,500

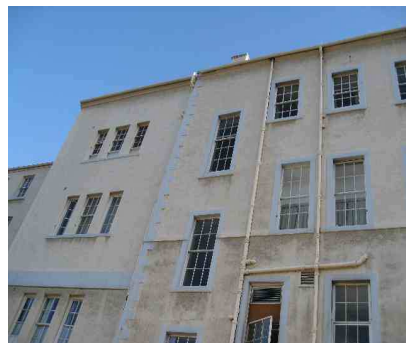
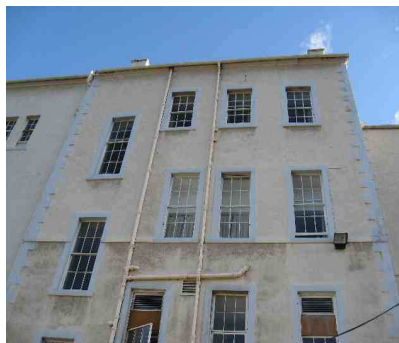
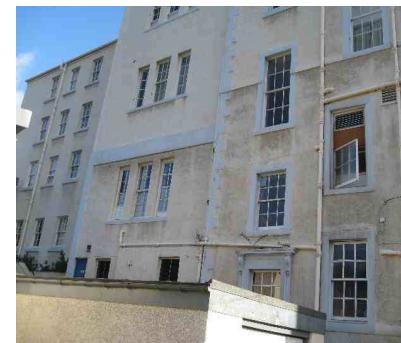
**Year 1
Repair Cost (£)****Photo 1**

**Element** : Windows**CODE** : 2**Description****Condition****Action****Cond/Ind Priority****L'Expec****Quantity****Replacement
Cost (£)**Timber softwood sash and case
single-glazed windowsFair, although general overhaul
required, including repairs and
replacement of missing and
snapped sash ropes

Overhaul windows

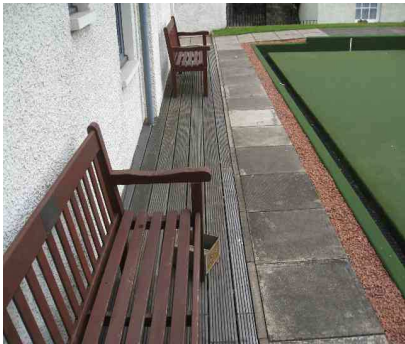
Photo 1

Element : Paths & Paving		CODE :3						Replacement Cost (£)	
Description	Condition	Action	Cond/Ind	Priority	L'Expec	Quantity		Year 1 Repair Cost (£)	
Timber finish	Fair	No Action Required	B		15	20	m2	820

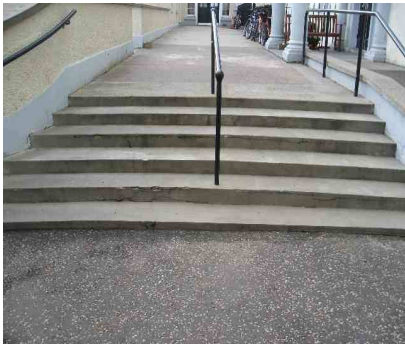
Photo 1

Element : Steps/ramps		CODE :3						Replacement Cost (£)	
Description	Condition	Action	Cond/Ind	Priority	L'Expec	Quantity		Year 1 Repair Cost (£)	
Concrete steps/ramps	Fair	No Action Required	B		20	68	m2	13,944

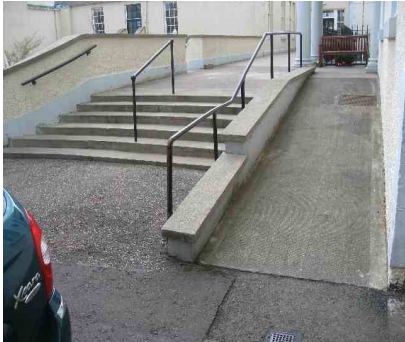
Photo 1

Description	Condition	Action	Cond/Ind	Priority	L'Expec	Quantity	Replacement Cost (£)	Year 1 Repair Cost (£)
Metal handrails	Fair	No Action Required	B		15	10 m	683

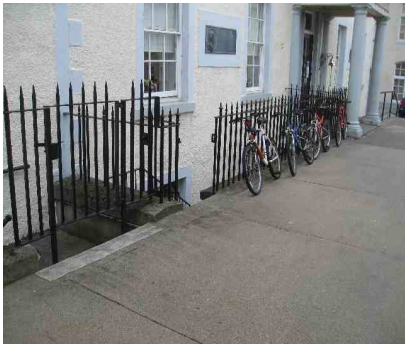
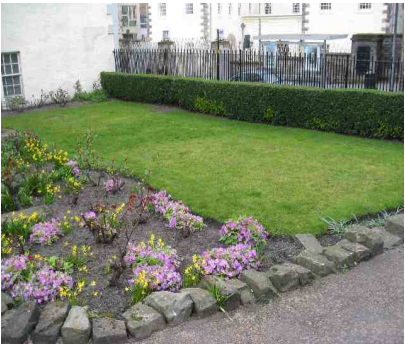
Description	Condition	Action	Cond/Ind	Priority	L'Expec	Quantity	Replacement Cost (£)	Year 1 Repair Cost (£)
Metal railings	Fair	No Action Required	B		15	46 m	5,030

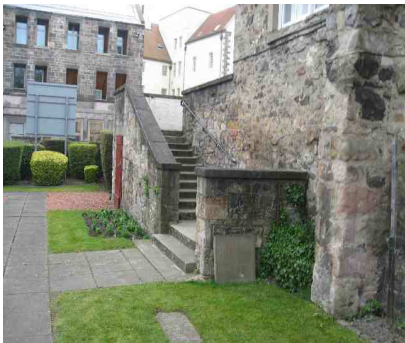
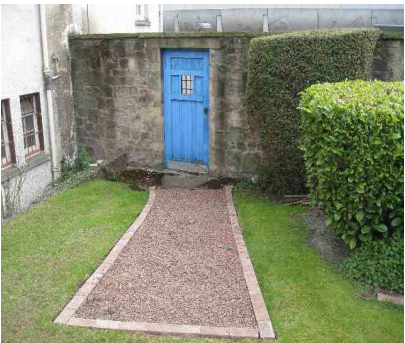
Description	Condition	Action	Cond/Ind	Priority	L'Expec	Quantity	Replacement Cost (£)	Year 1 Repair Cost (£)
Sandstone boundary wall	Fair	No Action Required	B		20	66 m2	27,068

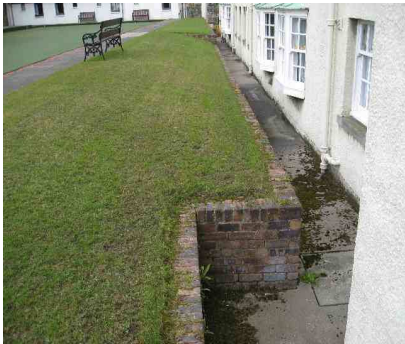
Photo 1

Description	Condition	Action	Cond/Ind	Priority	L'Expec	Quantity	Replacement Cost (£)	Year 1 Repair Cost (£)
Brick retaining wall	Fair	No Action Required	B		20	120 m2	26,248

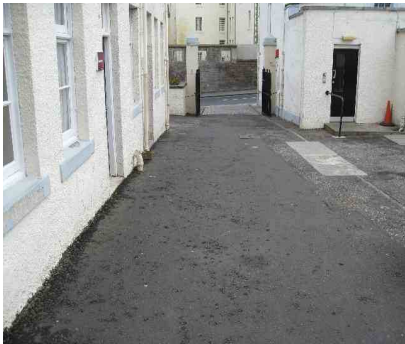
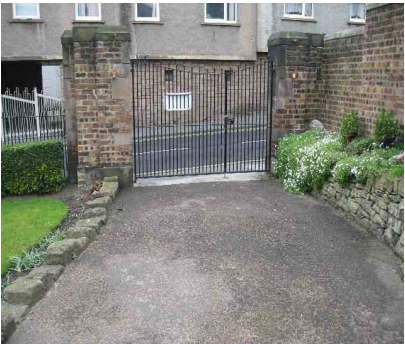
Description	Condition	Action	Cond/Ind	Priority	L'Expec	Quantity	Replacement Cost (£)	Year 1 Repair Cost (£)
Metal gates	Fair	No Action Required	B		15	7 m	7,000

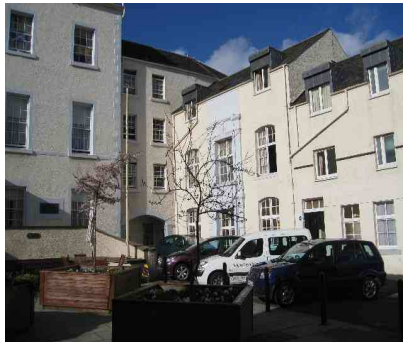
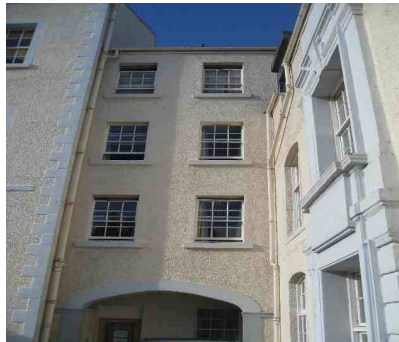
Description	Condition	Action	Cond/Ind	Priority	L'Expec	Quantity	Replacement Cost (£)	Year 1 Repair Cost (£)
Render finish (wet-dash)	Fair	No Action Required	B		10	32 m2	3,500

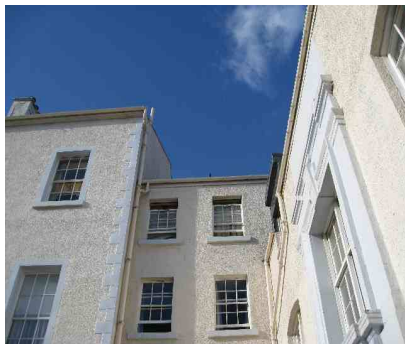
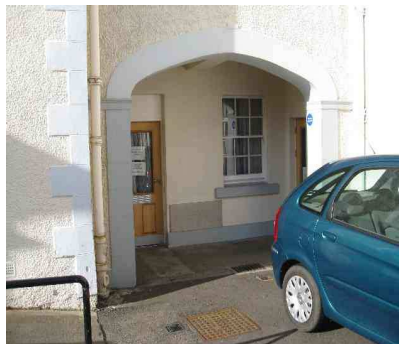
Description	Condition	Action	Cond/Ind	Priority	L'Expec	Quantity	Replacement Cost (£)	Year 1 Repair Cost (£)
Timber softwood sash and case single-glazed windows	Fair	No Action Required	B		10	11 m2	4,511

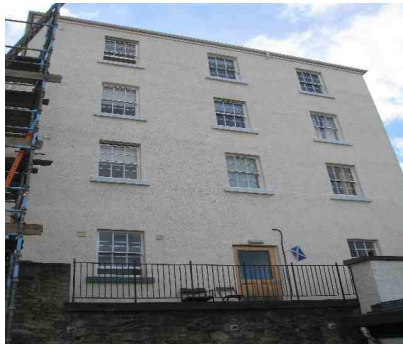
Photo 1

Description	Condition	Action	Cond/Ind	Priority	L'Expec	Quantity	Replacement Cost (£)	Year 1 Repair Cost (£)
Render finish (wet-dash)	Fair	No Action Required	B		10	53 m2	2,898

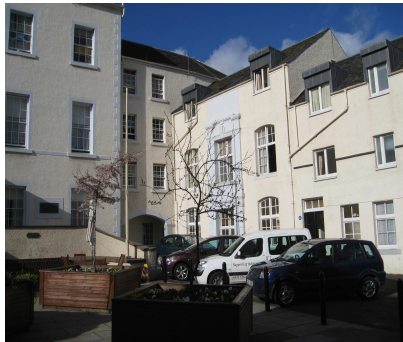
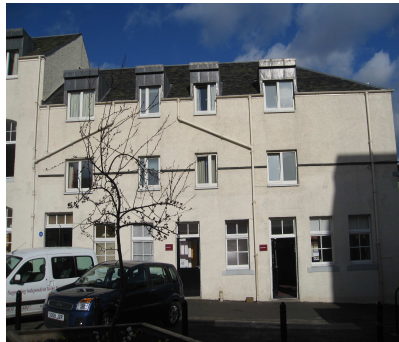
Description	Condition	Action	Cond/Ind	Priority	L'Expec	Quantity	Replacement Cost (£)	Year 1 Repair Cost (£)
Wet Dash	Fair	No Action Required	B		20	116 m2	6,343

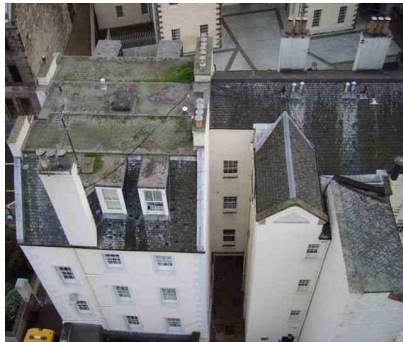
Photo 1

Description	Condition	Action	Cond/Ind	Priority	L'Expec	Quantity	Replacement Cost (£)	Year 1 Repair Cost (£)
Natural slate	Fair	No action required	B		20	36 m2	5,979

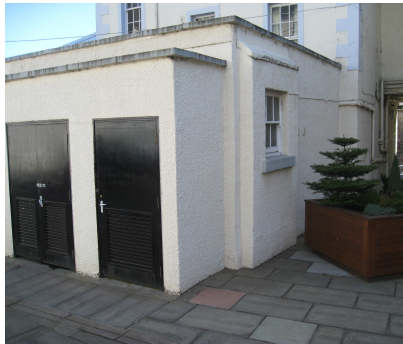
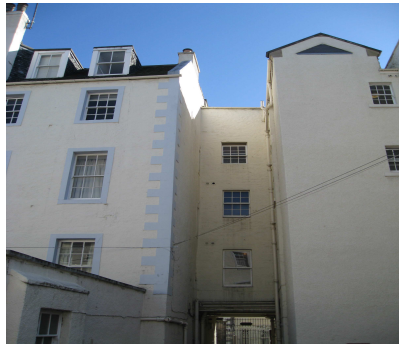
Description	Condition	Action	Cond/Ind	Priority	L'Expec	Quantity	Replacement Cost (£)	Year 1 Repair Cost (£)
Wet Dash	Fair	No Action Required	B		20	88 m2	4,812

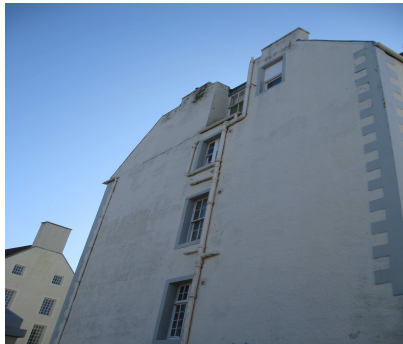
**Year 1
Repair Cost (£)****Photo 1**

**Photo 2****Position****Element** : External walls**CODE** :2**Description****Condition****Action****Cond/Ind Priority****L'Expec****Quantity****Replacement
Cost (£)**Window surrounds :cills,lintols
and jambs

Fair

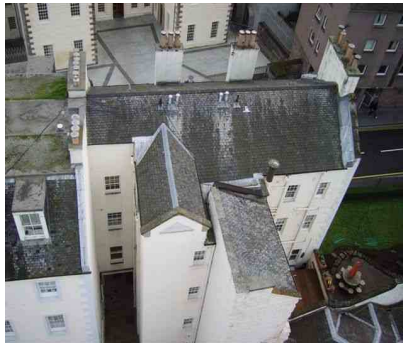
Photo 1

Description	Condition	Action	Cond/Ind	Priority	L'Expec	Quantity	Replacement Cost (£)	Year 1 Repair Cost (£)
Natural slate	Fair	No action required	B		45	15 m2	1,845

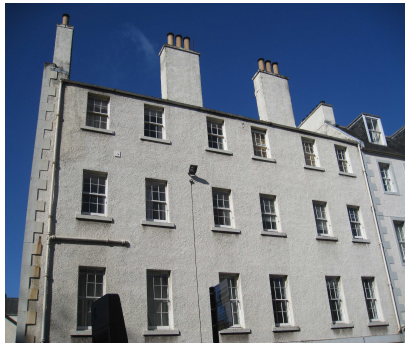
Photo 1

Description	Condition	Action	Cond/Ind	Priority	L'Expec	Quantity	Replacement Cost (£)	Year 1 Repair Cost (£)
Wet Dash	Fair	No Action Required	B		20	117 m2	6,398

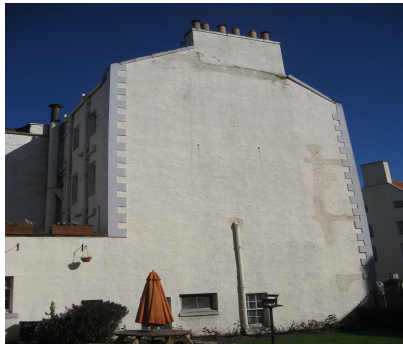
**Year 1
Repair Cost (£)****Photo 1**

**Photo 2****Position****Element** : Windows**CODE** :2**Description****Condition****Action****Cond/Ind****Priority****L'Expec****Quantity****Replacement
Cost (£)**3 No. Timber sash and case
(2m2)Fair but requires repainting
2 No cills require replacementRefer to decoration 2
Replace 2 No. cills

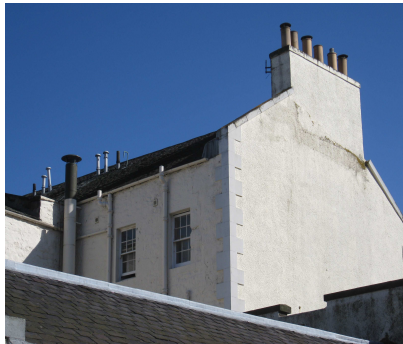
**Year 1
Repair Cost (£)****Photo 1**

**Photo 2****Position****Element** : Windows**CODE** : 2**Description****Condition****Action****Cond/Ind****Priority****L'Expec****Quantity****Replacement
Cost (£)**6 No. Timber sash and case
(2m2)

Fair but requires repainting

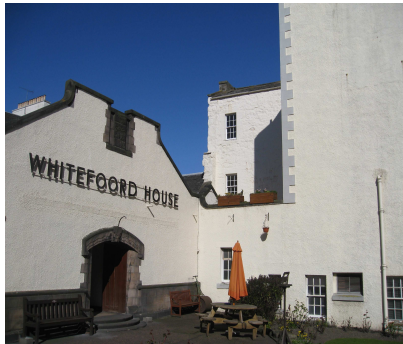
Photo 1

Description	Condition	Action	Cond/Ind	Priority	L'Expec	Quantity	Replacement Cost (£)	Year 1 Repair Cost (£)
Stone wall, painted	Fair	No Action Required	B		35	50 m2	8,886

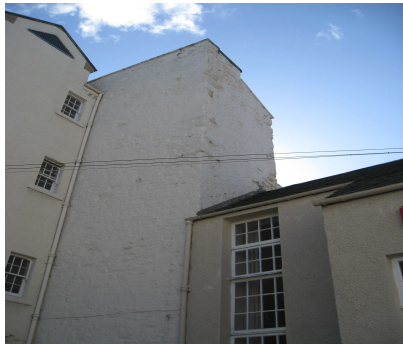
Photo 1

Element : External walls		CODE : 2						Replacement Cost (£)
Description	Condition	Action	Cond/Ind	Priority	L'Expec	Quantity		
Stone wall, painted	Fair	No Action Required	B		35	21	m2	3,732
								Year 1 Repair Cost (£)

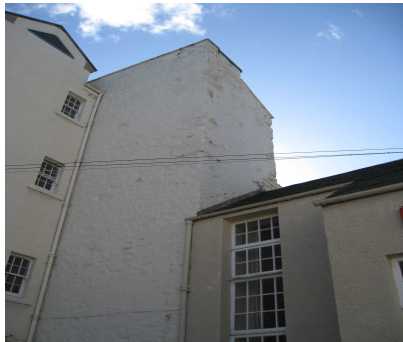
Photo 1

Element : External walls		CODE : 2						Replacement Cost (£)
Description	Condition	Action	Cond/Ind	Priority	L'Expec	Quantity		
Stone wall, painted	Fair	No Action Required	B		35	44	m2	7,819
								Year 1 Repair Cost (£)

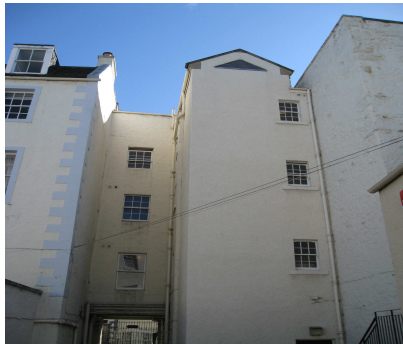
Photo 1

Description	Condition	Action	Cond/Ind	Priority	L'Expec	Quantity	Replacement Cost (£)	Year 1 Repair Cost (£)
Wet Dash	Fair	No Action Required	B		20	33 m2	1,804

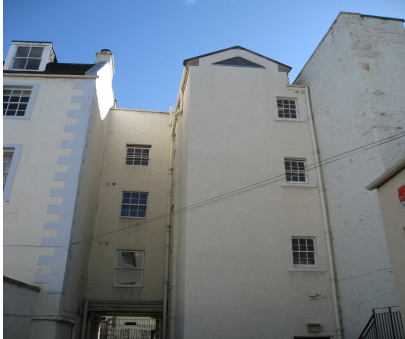
Element : External walls		CODE : 2						Replacement Cost (£)
Description	Condition	Action	Cond/Ind	Priority	L'Expec	Quantity		Year 1 Repair Cost (£)
Wet Dash	Fair	No Action Required	B		20	24	m2	1,312
Photo 1		Photo 2		Position

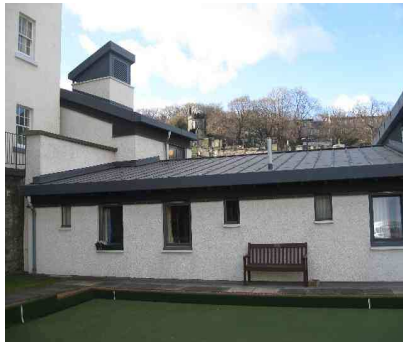
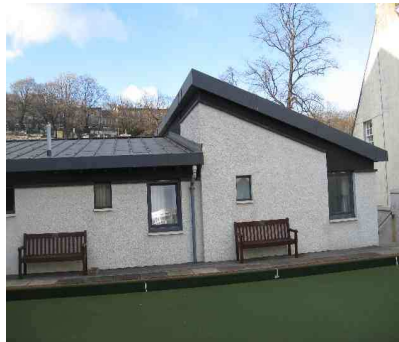
Description	Condition	Action	Cond/Ind	Priority	L'Expec	Quantity	Replacement Cost (£)	Year 1 Repair Cost (£)
Render finish (wet-dash)	Fair	No Action Required	B		32	38 m2	2,077

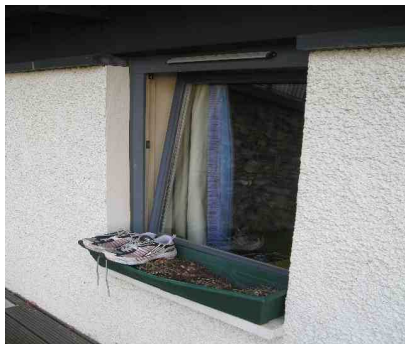
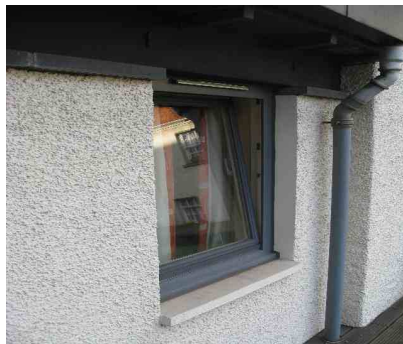
Description	Condition	Action	Cond/Ind	Priority	L'Expec	Quantity	Replacement Cost (£)	Year 1 Repair Cost (£)
Timber softwood casement double-glazed windows	Fair	No Action Required	B		27	6 m2	2,952

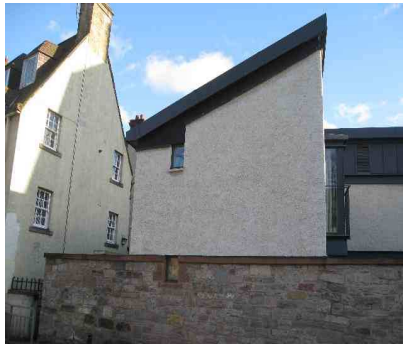
Photo 1

Element : External walls	CODE : 2							
Description	Condition	Action	Cond/Ind	Priority	L'Expec	Quantity		Replacement Cost (£)
Render finish (wet-dash)	Fair	No Action Required	B		32	12 m2		656
								Year 1 Repair Cost (£)

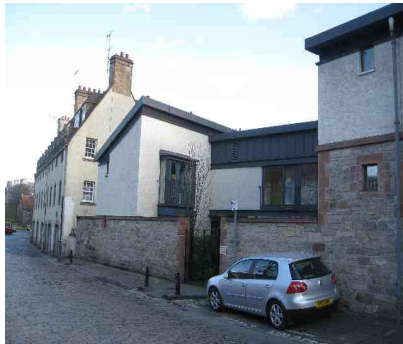
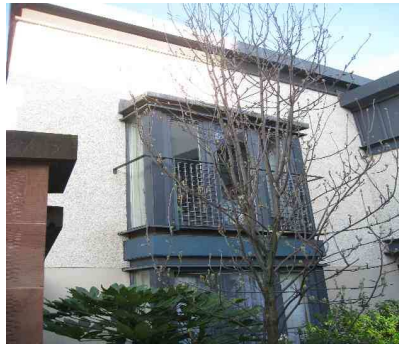
Description	Condition	Action	Cond/Ind	Priority	L'Expec	Quantity	Replacement Cost (£)	Year 1 Repair Cost (£)
Render finish (wet-dash)	Fair	No Action Required	B		32	15 m2	820

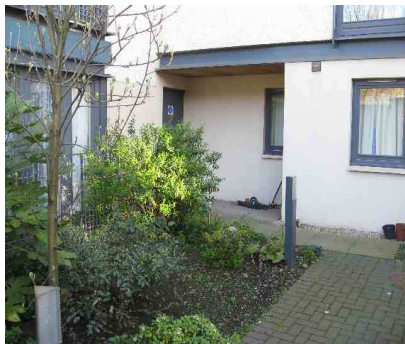
Photo 1

Description	Condition	Action	Cond/Ind	Priority	L'Expec	Quantity	Replacement Cost (£)	Year 1 Repair Cost (£)
Softwood timber flush/glazed door	Fair	No Action Required	B		17	1 No.	984

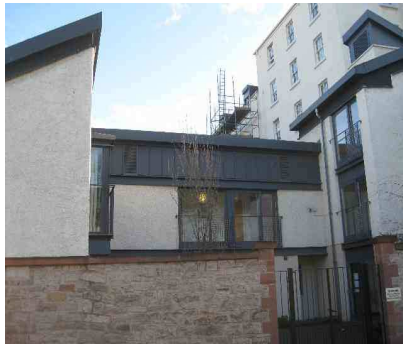
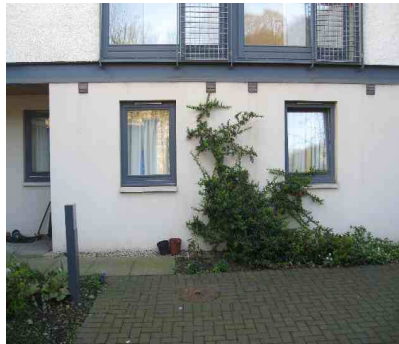
Description	Condition	Action	Cond/Ind	Priority	L'Expec	Quantity	Replacement Cost (£)	Year 1 Repair Cost (£)
Render finish (wet-dash)	Fair	No Action Required	B		32	36 m2	1,968

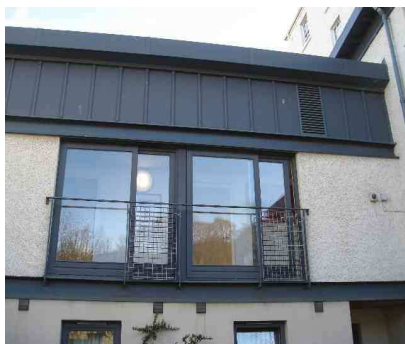
Photo 1

Description	Condition	Action	Cond/Ind	Priority	L'Expec	Quantity	Replacement Cost (£)	Year 1 Repair Cost (£)
Softwood timber patio doors	Fair	No Action Required	B		17	4 No.	4,000

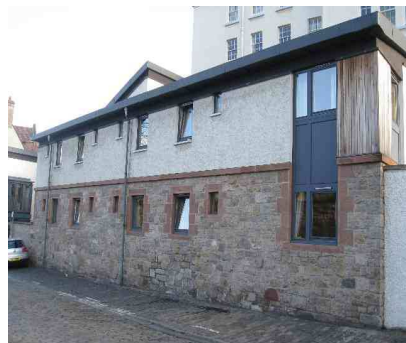
Photo 1

Element : External walls		CODE : 2						
Description	Condition	Action	Cond/Ind	Priority	L'Expec	Quantity		Replacement Cost (£)
Render finish (wet-dash)	Fair	No Action Required	B		32	44 m2		2,406
								Year 1 Repair Cost (£)

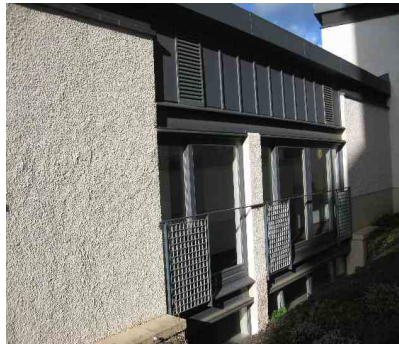
**Position****Element** : Windows**CODE** :2**Description****Condition****Action****Cond/Ind****Priority****L'Expec****Quantity****Replacement
Cost (£)**Timber softwood casement
double-glazed windows

Fair

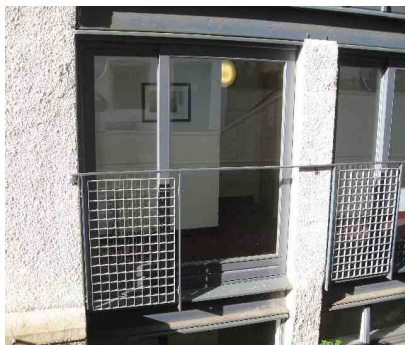
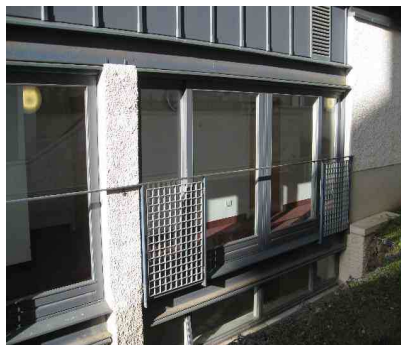
Element : Decoration

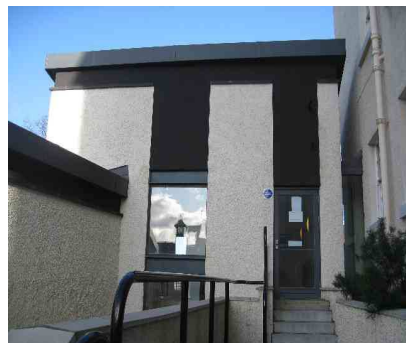
Element : Windows	CODE : 2							
Description	Condition	Action	Cond/Ind	Priority	L'Expec	Quantity		Replacement Cost (£)
Timber softwood casement double-glazed windows	Fair	No Action Required	B		27	4 m2		1,968
								Year 1 Repair Cost (£)

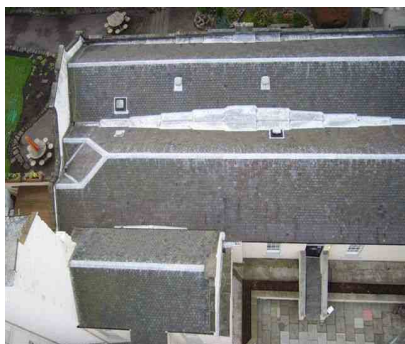
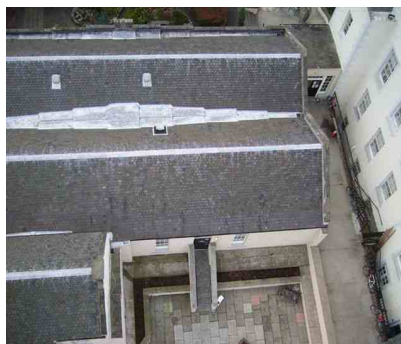
Element : Covering

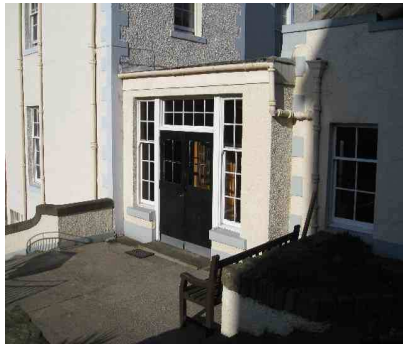
**Photo 2****Position****Element** : Decoration**CODE** :2**Description****Condition****Action****Cond/Ind****Priority****L'Expec****Quantity****Replacement
Cost (£)**

Re-decoration

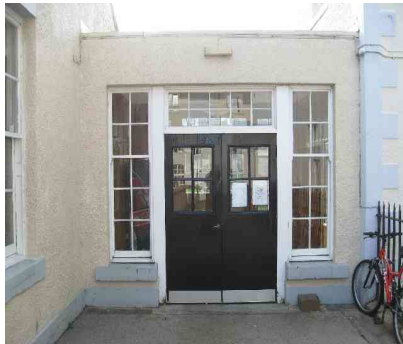
**Photo 2****Position****Element** : Windows**CODE** :2**Description****Condition****Action****Cond/Ind Priority****L'Expec****Quantity****Replacement
Cost (£)**2 No.Timber sash and case
single glazed (2m2)

Fair

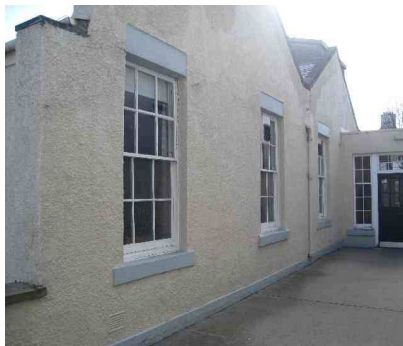
**Photo 2****Position****Element** : Windows**CODE** :2**Description****Condition****Action****Cond/Ind****Priority****L'Expec****Quantity****Replacement
Cost (£)**3 No.Timber sash and case
single glazed (2m2)

Fair

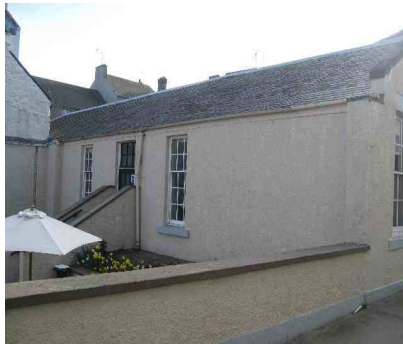
**Photo 2****Position****Element** : Windows**CODE** :2**Description****Condition****Action****Cond/Ind Priority****L'Expec****Quantity****Replacement
Cost (£)**2 No.Timber sash and case
single glazed (2m2)

Fair

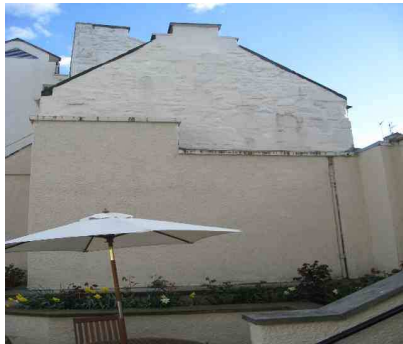
**Photo 2****Position****Element** : External walls**CODE** :2**Description****Condition****Action****Cond/Ind****Priority****L'Expec****Quantity****Replacement
Cost (£)**

Stone wall

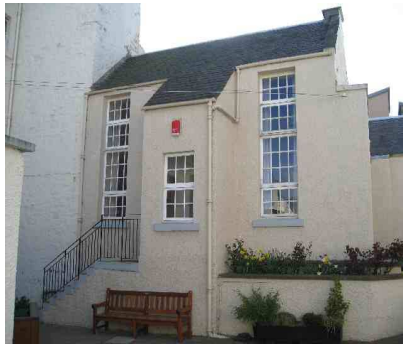
**Photo 2****Position****Element** : Windows**CODE** :2**Description****Condition****Action****Cond/Ind****Priority****L'Expec****Quantity****Replacement
Cost (£)**2 No.Timber casement single
glazed (3m2)

Fair but with patching to cill

**Year 1
Repair Cost (£)**
100

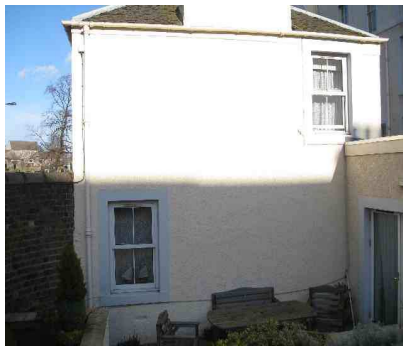
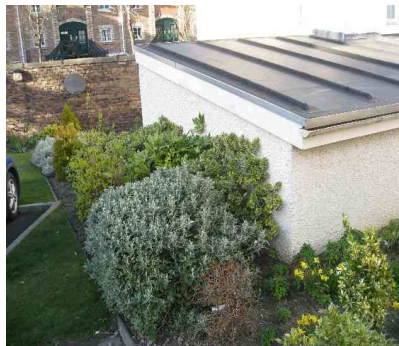
**Position****Element** : Windows**CODE** :2**Description****Condition****Action****Cond/Ind****Priority****L'Expec****Quantity****Replacement
Cost (£)**PVC-u casement double-glazed
windows

Fair

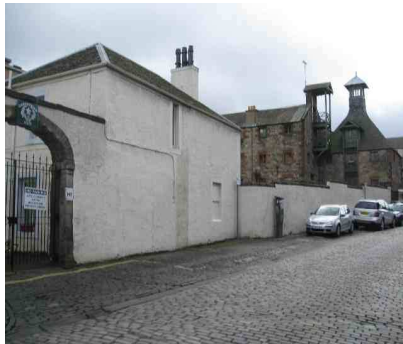
**Photo 2****Position****Element** : Windows**CODE** :2**Description****Condition****Action****Cond/Ind Priority****L'Expec****Quantity****Replacement
Cost (£)**

PVC-u casement double-glazed windows

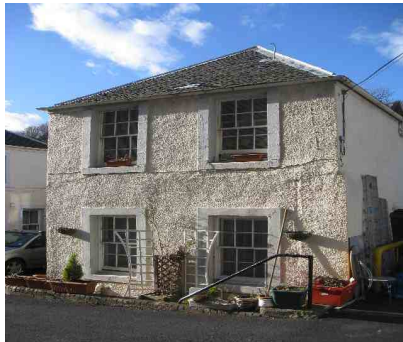
Photo 1

Description	Condition	Action	Cond/Ind	Priority	L'Expec	Quantity	Replacement Cost (£)	Year 1 Repair Cost (£)
Roughcast finish	Fair, although slight cracking at window ingoe	Make good finish	B	4	10	16 m2	874	100
